HUNTLEY ASSOCIATES, P.C.
SURVEYORS • ENGINEERS • LANDSCAPE ARCHITECTS

January 20, 2009

**RE: *Structural Evaluation of Elevated Apparatus Bay Floor; Greenfield Fire House, Greenfield MA
SEA Project No. S09-018***

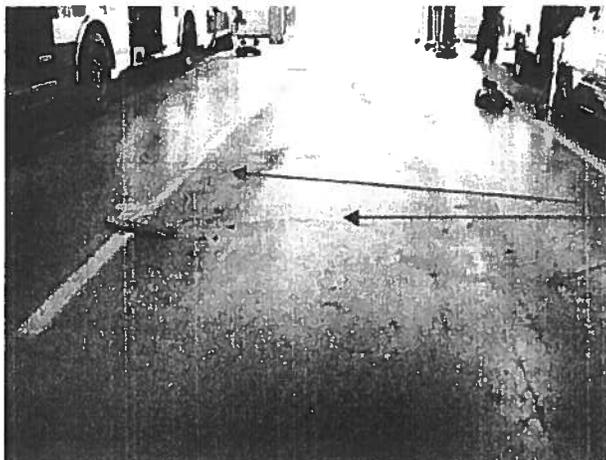
As for the observed cracking and deterioration within the concrete topping and original waffle slab, HAPC offers the following. It is HAPC's professional opinion that the cracking observed at the bay entrances and over the existing interior concrete waffle slab beam/new reinforced steel girder locations are a direct result of reverse bending taking place within the concrete topping and the lack of proper jointing at these locations. As the slab system between these locations would deflect downward under load, the concrete topping at the crack locations (prior to the cracking occurring) would experience reverse bending, thus, introducing tensile stresses into the concrete topping material. Due to the limiting thickness of the concrete topping, these tensile stresses were likely too great, thereby, causing the concrete topping to crack. The other noted slab cracks and "spider web" cracking noted within the concrete topping are believed to also be a result of the slab system's natural downward deflection and the topping's age. The use of the existing apparatus bays for cleaning of the fire trucks (particularly in the winter time) allows water and potentially road salt to enter the cracks (further deteriorating them) and migrate down to the reinforced waffle slab and steel support system below, thereby, causing and breeding more corrosion/deterioration of the steel reinforcing within the concrete (causing additional concrete spalling) and the structural steel support system.

View of the elevated apparatus bay floor 2" concrete topping which is cracking and rutting from continually use.

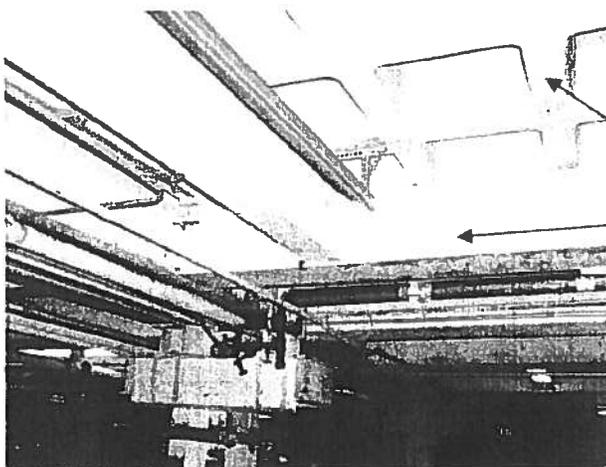
Overall underside view of the concrete waffle slab and how it is supported/reinforced by steel beam and girder members.
