December 2014

FRANKLIN
REGIONAL
COUNCIL OF
GOVERNMENTS

SLUM AND BLIGHT INVENTORY FOR THE TOWN OF GREENFIELD

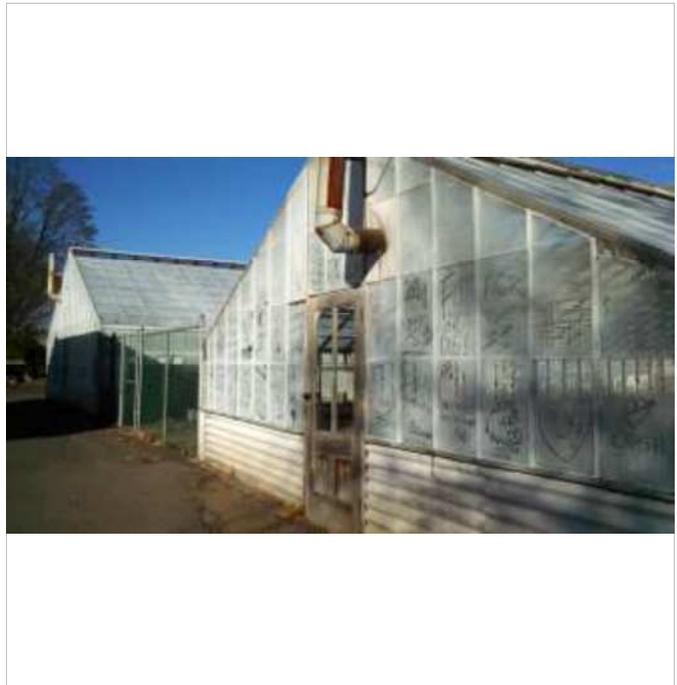
ID:

Roofing:	<input type="text"/>
Windows and Doors:	Broken glass. FAIR
Exterior Walls:	Broken glass and graffiti. Torn and rusted aluminum. POOR
Porch, Stairs, Deck:	<input type="text"/>
Foundation:	<input type="text"/>
Storefront/Signage:	<input type="text"/>
Parking Lots:	gravel
Other Conditions:	<input type="text"/>
Overall Property Rating:	Poor

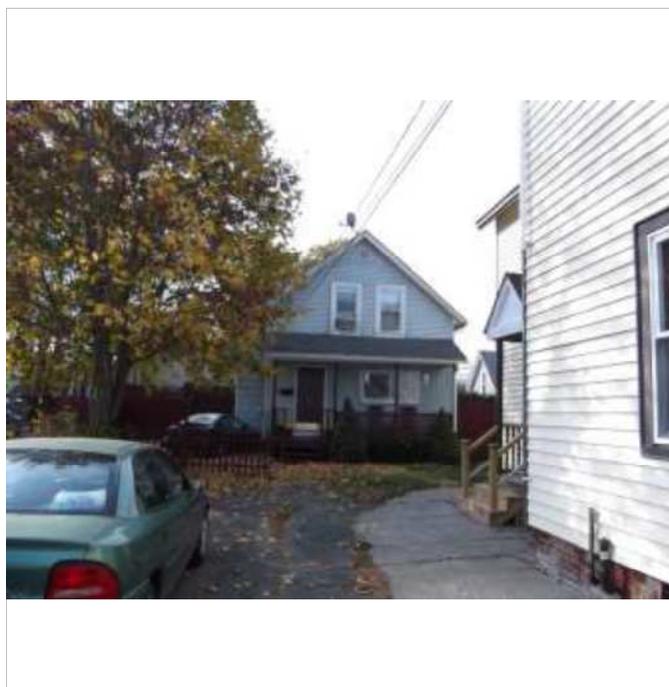
ID:

Roofing:	Asphalt shingles with loose, broken flashing. FAIR
Windows and Doors:	Original, very energy inefficient windows. FAIR
Exterior Walls:	Vinyl is GOOD
Porch, Stairs, Deck:	Porch is freshly painted. GOOD
Foundation:	Brick is GOOD
Storefront/Signage:	
Parking Lots:	
Other Conditions:	
Overall Property Rating:	Fair

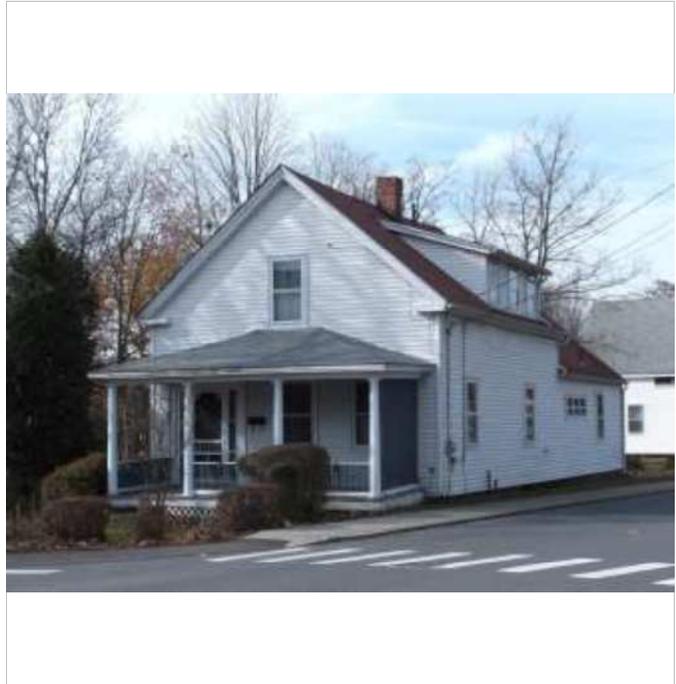
Roofing:	Roofline is bowed and chimney is leaning. FAIR-POOR
Windows and Doors:	Newer storm windows. GOOD
Exterior Walls:	Vinyl siding is GOOD.
Porch, Stairs, Deck:	Front door is very old and needs replacement. Fascia on porch is rotting with peeling paint. FAIR
Foundation:	Brick is GOOD
Storefront/Signage:	
Parking Lots:	
Other Conditions:	
Overall Property Rating:	Fair

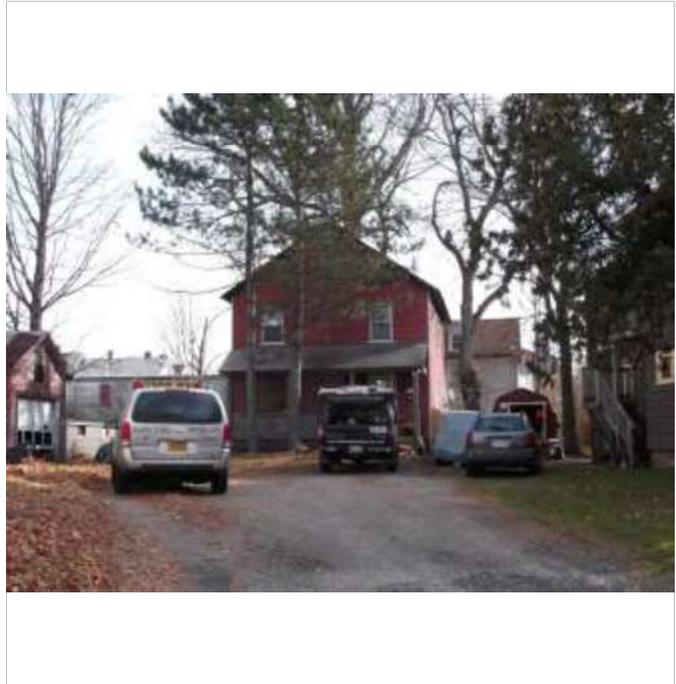
<u>Component</u>	<u>Condition</u>
Roofing:	Slate roof is loose. Wood fascia is rotted along roof line. POOR
Windows and Doors:	Older windows that are energy inefficient. FAIR
Exterior Walls:	Aluminum siding is GOOD
Porch, Stairs, Deck:	Lattice is coming off porch. GOOD
Foundation:	Brick is chipped. FAIR
Storefront/Signage:	
Parking Lots:	
Other Conditions:	
Overall Property Rating:	Fair

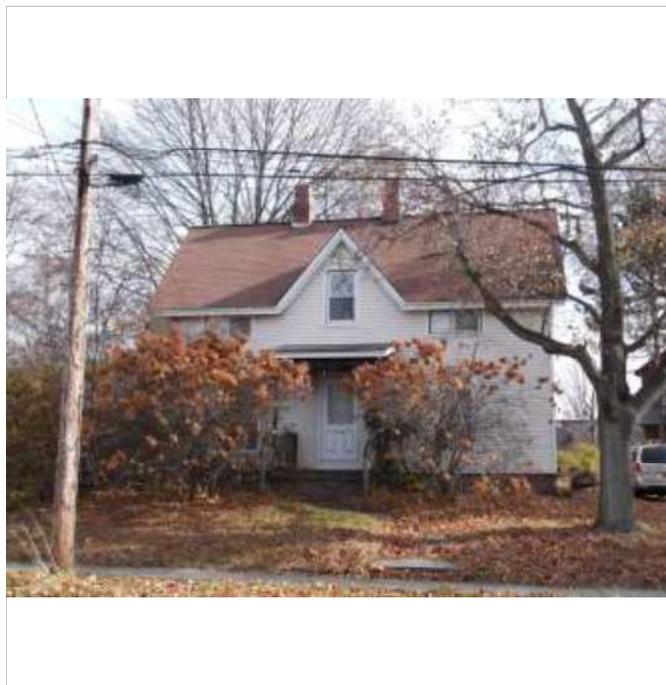
<u>Component</u>	<u>Condition</u>
Roofing:	More than 25% of asphalt shingles are lifting off and becoming loose. Roofline is bowed. Flashing is loose around chimney. POOR
Windows and Doors:	Windows have storm windows and are in GOOD condition.
Exterior Walls:	Vinyl siding is GOOD
Porch, Stairs, Deck:	Porch roof has rotted wood and older shingles. FAIR
Foundation:	50% of brick foundations are cracked. POOR
Storefront/Signage:	
Parking Lots:	
Other Conditions:	
Overall Property Rating:	Fair

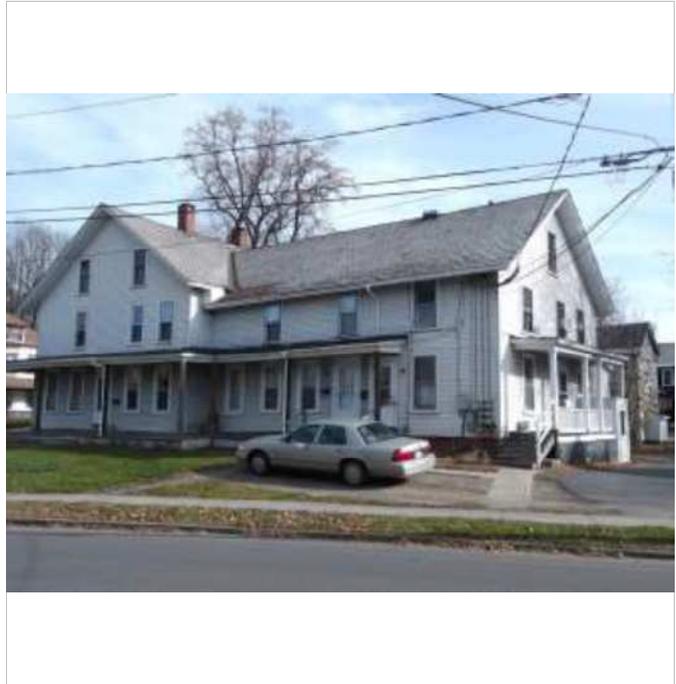
Roofing:	More than 50% slate shingles are loose, cracked, missing. Bowed roofline and rusted metal flashing. Chimney cap is cracked. POOR
Windows and Doors:	Very old windows with rotted trim and peeling paint. POOR
Exterior Walls:	Vinyl siding is older and needs powerwashing. Some vinyl is coming loose. FAIR
Porch, Stairs, Deck:	Porch fascia is rotted and peeling. The porch floor is uneven and bowed. POOR
Foundation:	Brick is GOOD
Storefront/Signage:	<input type="text"/>
Parking Lots:	<input type="text"/>
Other Conditions:	<input type="text"/>
Overall Property Rating:	Poor

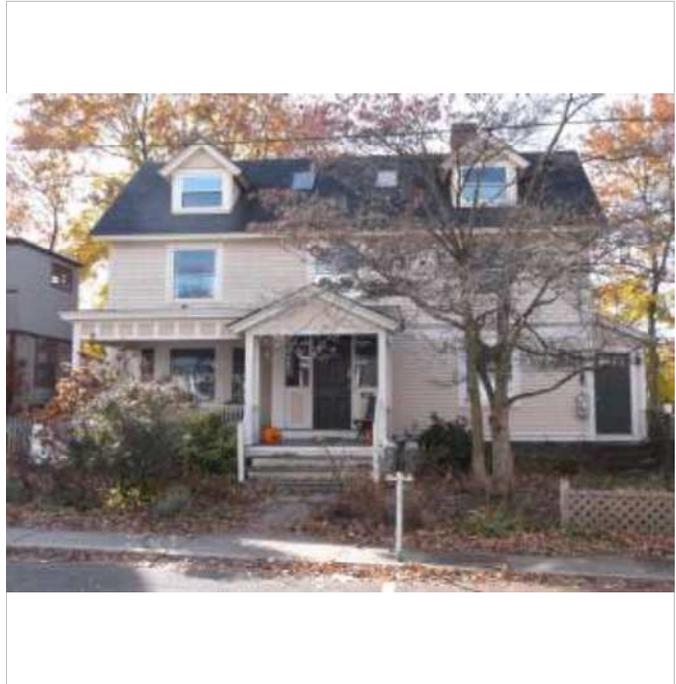
Roofing:	Asphalt shingles are GOOD
Windows and Doors:	Windows have been recently replaced. GOOD
Exterior Walls:	There is some paint peeling near bottom, but less than 25%. GOOD
Porch, Stairs, Deck:	GOOD
Foundation:	Brick is GOOD
Storefront/Signage:	
Parking Lots:	
Other Conditions:	
Overall Property Rating:	Good

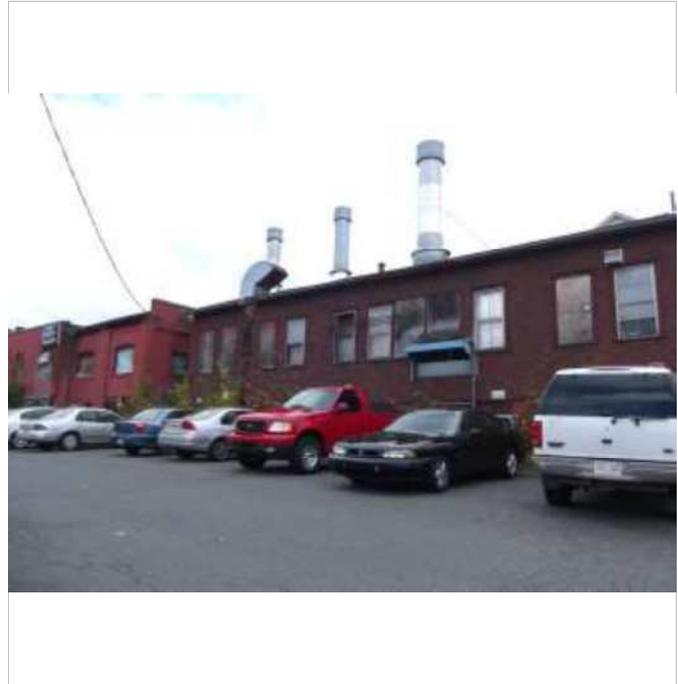
Roofing:	Torn and missing flashing. POOR
Windows and Doors:	Windows are either boarded up or broken. POOR
Exterior Walls:	Shingles are lifting away, loose, and torn. POOR
Porch, Stairs, Deck:	
Foundation:	Brick foundation needs repointing. Loose bricks. POOR
Storefront/Signage:	Outdated signage. FAIR
Parking Lots:	
Other Conditions:	
Overall Property Rating:	Poor

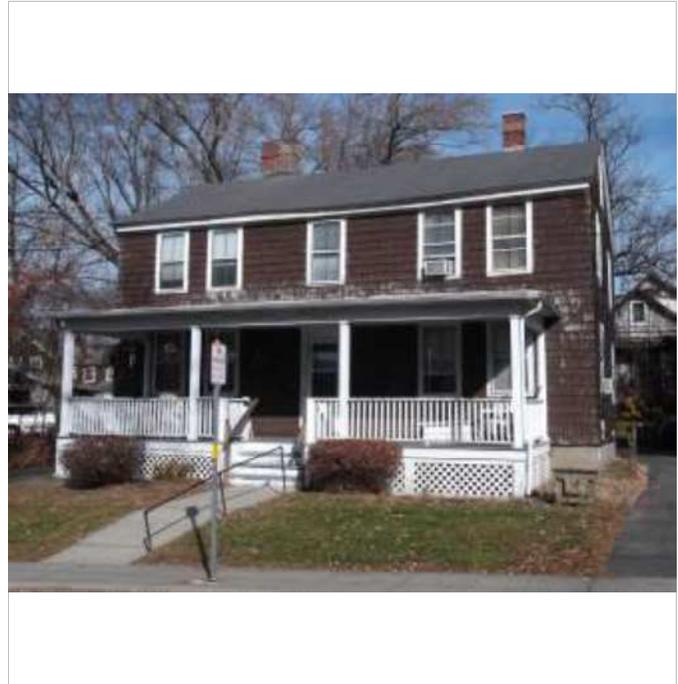
Roofing:	Asphalt shingles are beyond useful life. Roof is bowed. Flashing is missing around chimney. POOR
Windows and Doors:	Windows have peeling paint and are older. POOR
Exterior Walls:	Shingles are past useful life, with some loose and rotting. At least 25% of paint is peeling. POOR
Porch, Stairs, Deck:	Paint is very faded and peeling. POOR
Foundation:	Concrete is chipping. FAIR
Storefront/Signage:	<input type="text"/>
Parking Lots:	<input type="text"/>
Other Conditions:	<input type="text"/>
Overall Property Rating:	Poor

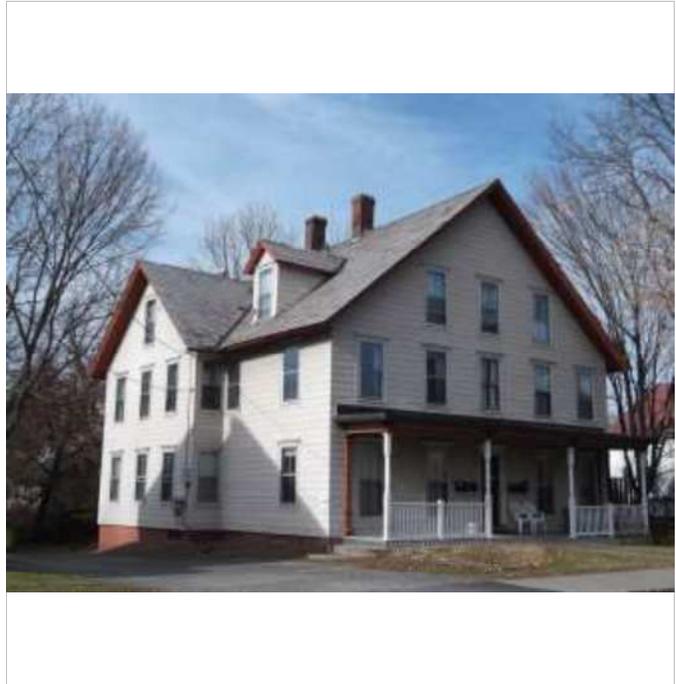
Roofing:	Many slate shingles are broken, chipped. Chimney is missing mortar. Flashing is loose and missing. POOR
Windows and Doors:	Window trims have peeling and rotting. Older windows are very energy inefficient. FAIR
Exterior Walls:	25% of siding is chipped and broken. FAIR
Porch, Stairs, Deck:	Porch floor is bowed with loose floorboards. FAIR
Foundation:	Brick has peeling paint and 25% needs repointing. FAIR
Storefront/Signage:	<input type="text"/>
Parking Lots:	<input type="text"/>
Other Conditions:	<input type="text"/>
Overall Property Rating:	Fair

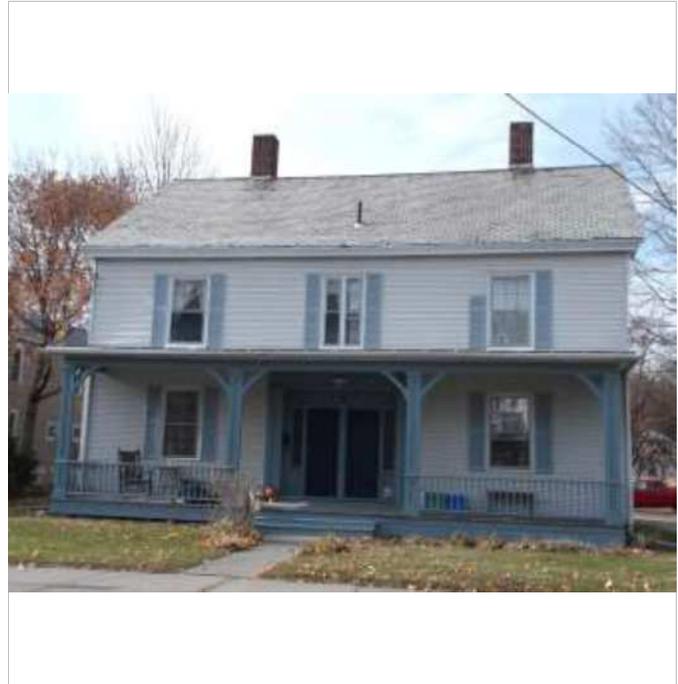
57-51

<u>Component</u>	<u>Condition</u>
Roofing:	More than 50% of slate shingles are loose, worn, or cracked. Both chimneys have poor flashing and missing mortar. POOR
Windows and Doors:	Older windows with loose-fitting storms and broken shutters. FAIR
Exterior Walls:	Vinyl siding is GOOD
Porch, Stairs, Deck:	GOOD
Foundation:	Brick foundation has some bowing. FAIR
Storefront/Signage:	
Parking Lots:	
Other Conditions:	
Overall Property Rating:	Fair

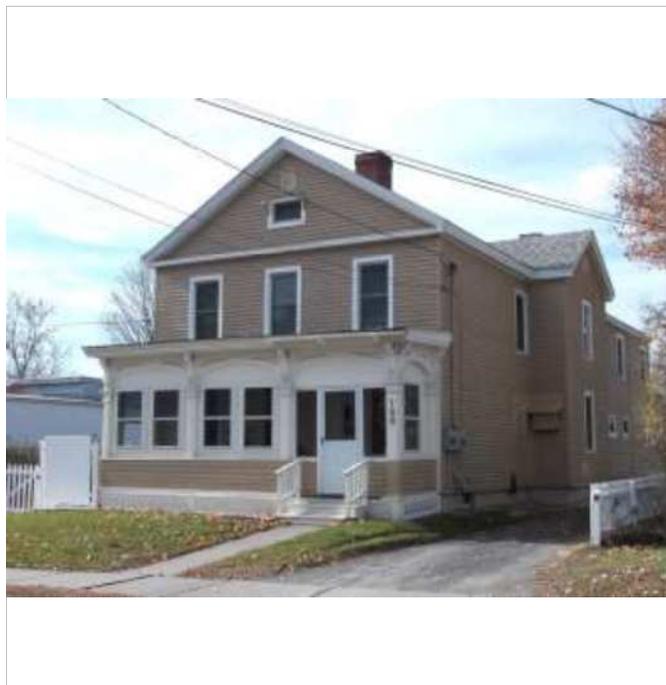
<u>Component</u>	<u>Condition</u>
Roofing:	New asphalt. GOOD
Windows and Doors:	Windows have storms with freshly painted trims. GOOD
Exterior Walls:	Wood clapboard is good and freshly painted. GOOD
Porch, Stairs, Deck:	GOOD
Foundation:	Brick is freshly painted. GOOD
Storefront/Signage:	
Parking Lots:	
Other Conditions:	
Overall Property Rating:	Good

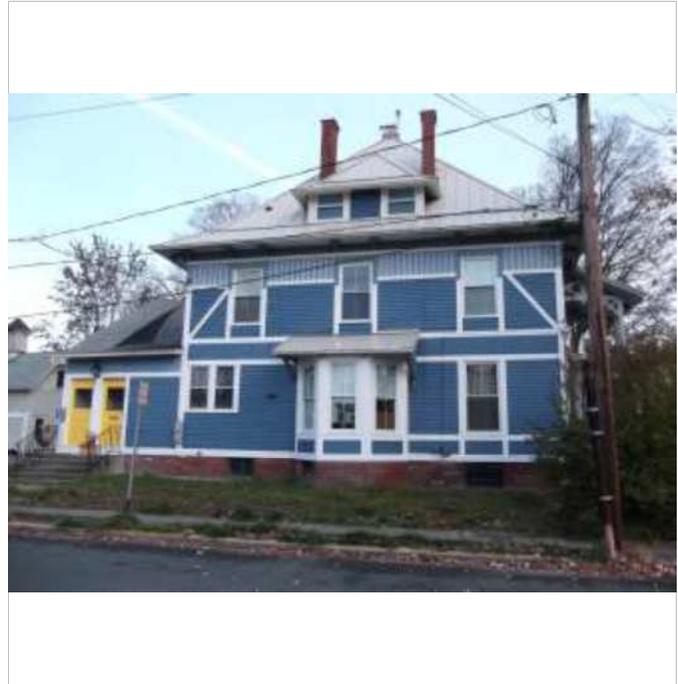
59-20

Roofing:	Tin roof. GOOD
Windows and Doors:	Replacement windows. GOOD
Exterior Walls:	Siding has been freshly painted. GOOD
Porch, Stairs, Deck:	Porch is being help up by jacks. POOR
Foundation:	Older brick foundation needs repointing. FAIR
Storefront/Signage:	
Parking Lots:	
Other Conditions:	
Overall Property Rating:	Good

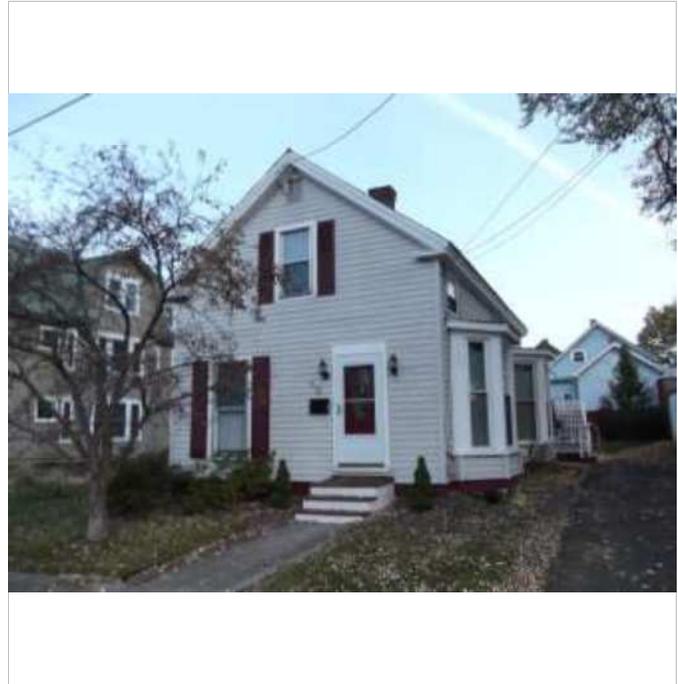
59-19

Roofing:	More than 50% of asphalt shingles are broken, missing, lifting away. POOR
Windows and Doors:	Original windows are leaky/energy inefficient. FAIR
Exterior Walls:	Vinyl is in GOOD condition.
Porch, Stairs, Deck:	GOOD
Foundation:	Brick is GOOD
Storefront/Signage:	
Parking Lots:	
Other Conditions:	
Overall Property Rating:	Fair-Good

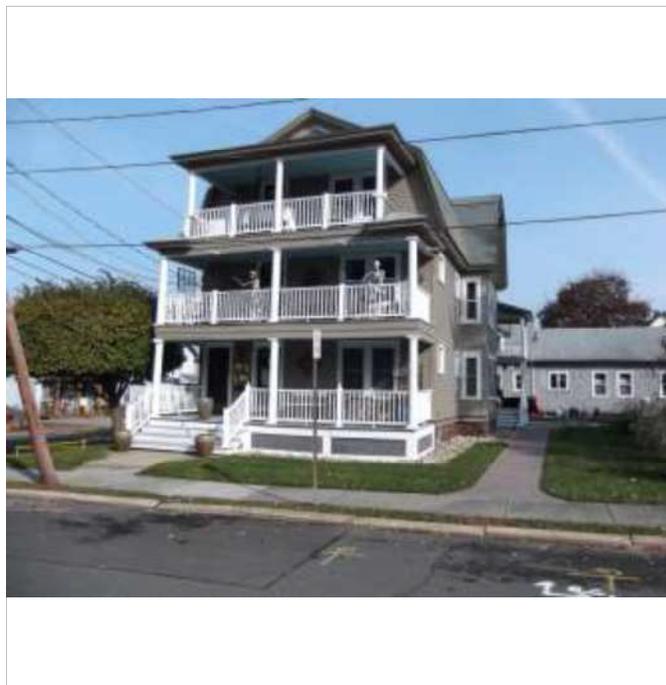
Roofing:	25% of asphalt shingles are broken or missing. FAIR
Windows and Doors:	Original, very energy inefficient windows. FAIR
Exterior Walls:	Freshly painted. GOOD
Porch, Stairs, Deck:	Newly repainted. GOOD
Foundation:	Stone foundation has no cracks. GOOD
Storefront/Signage:	
Parking Lots:	
Other Conditions:	
Overall Property Rating:	Good

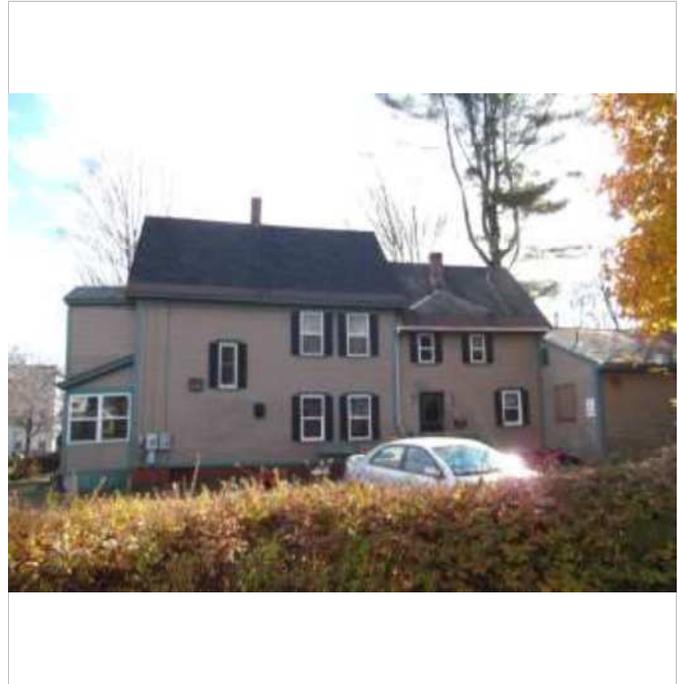
64-69

Roofing:	More than 25% of asphalt shingles are in need of repair. Chimney bricks and flashing are loose. FAIR
Windows and Doors:	Replacement windows. GOOD
Exterior Walls:	More than 25% of paint is peeling. Some rottnig and loose boards. FAIR
Porch, Stairs, Deck:	Porch is sagging off the face of the house. It is rotting and unsafe. POOR
Foundation:	25% of bricks are cracked. Some are loose. The foundation to the porch is leaning out and bowed. FAIR-POOR
Storefront/Signage:	
Parking Lots:	
Other Conditions:	
Overall Property Rating:	Fair

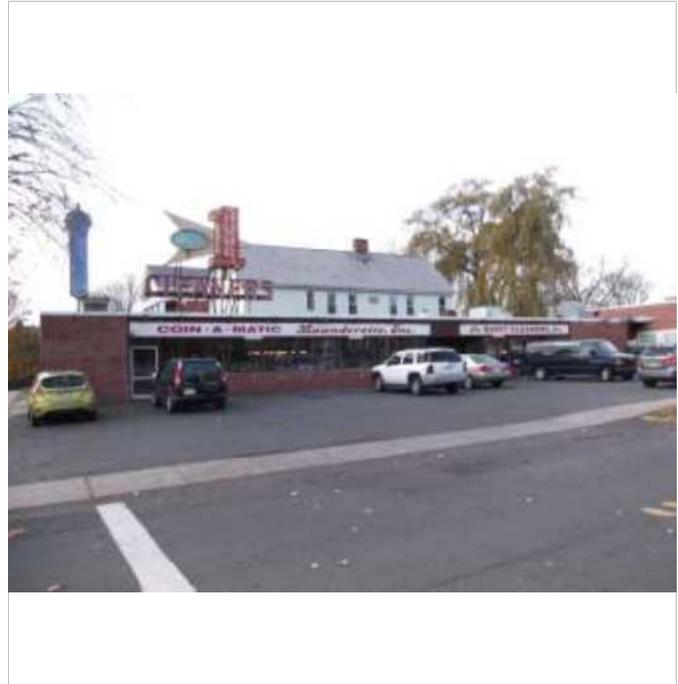
59-80

Roofing:	Flat roof with peeling flashing. POOR
Windows and Doors:	Doors are rusty and older. Windows are good. FAIR
Exterior Walls:	Brick is GOOD
Porch, Stairs, Deck:	GOOD
Foundation:	Can't see
Storefront/Signage:	Older signage. GOOD
Parking Lots:	Asphalt is cracked, but less than 25%. GOOD
Other Conditions:	
Overall Property Rating:	Fair

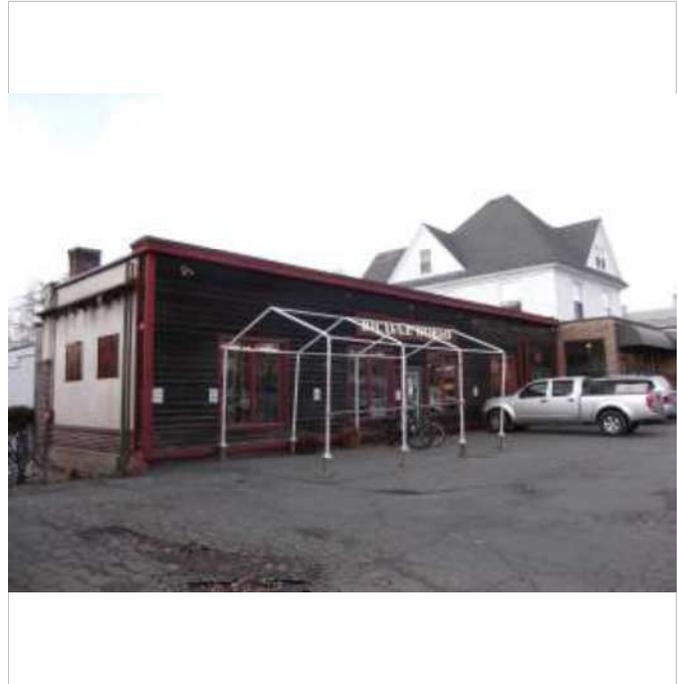
<u>Component</u>	<u>Condition</u>
Roofing:	Chimney needs repointing. POOR
Windows and Doors:	Side windows are boarded up. Front door has rotted frame and peeled paint. FAIR
Exterior Walls:	Decorative overhang is rotted. Front clapboard is uneven. FAIR
Porch, Stairs, Deck:	
Foundation:	Cinderblock is loose on side. FAIR
Storefront/Signage:	Storefront windows have gaps in trim. FAIR
Parking Lots:	Large cracks and holes. POOR
Other Conditions:	
Overall Property Rating:	Fair

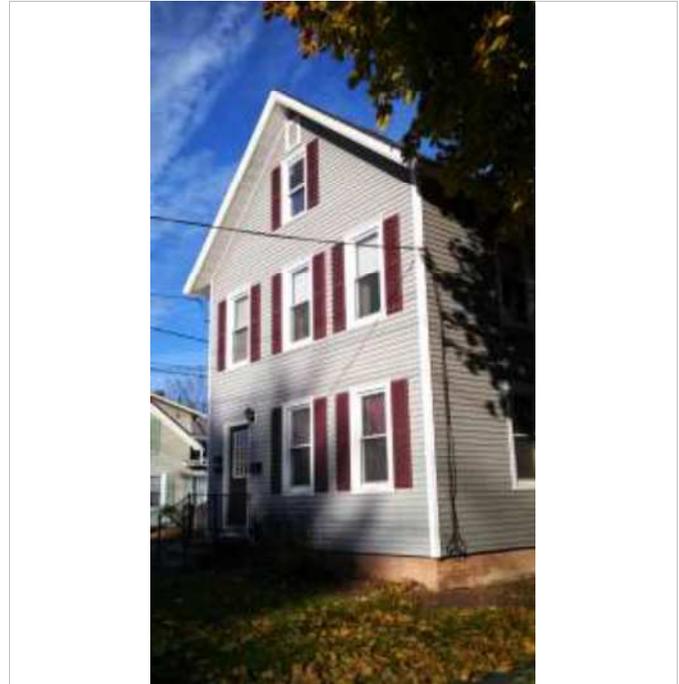
64-28

<u>Component</u>	<u>Condition</u>
Roofing:	Asphalt shingles. GOOD
Windows and Doors:	Newer replacement windows. GOOD
Exterior Walls:	Newer vinyl siding. GOOD
Porch, Stairs, Deck:	GOOD
Foundation:	Brick. 50% of bricks need repointing, flaking brick. One wall is bowed out. POOR
Storefront/Signage:	
Parking Lots:	
Other Conditions:	
Overall Property Rating:	Good

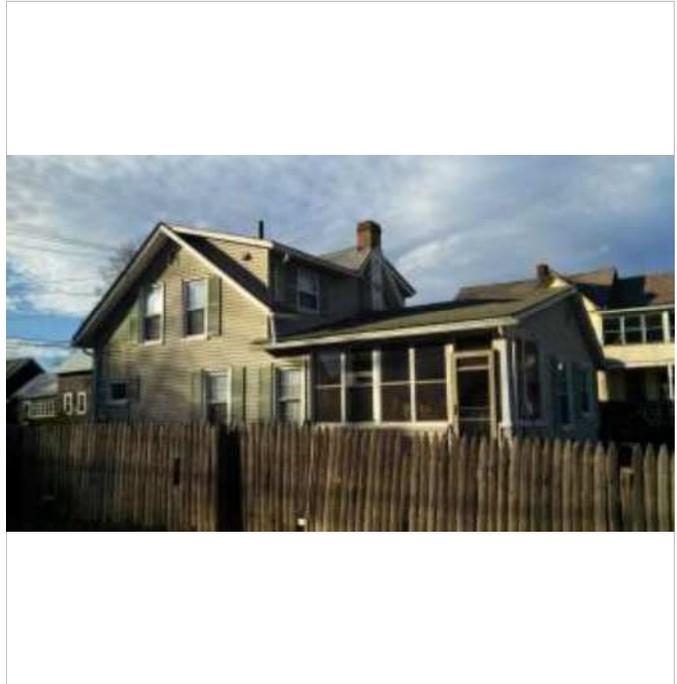
Roofing:	Newer asphalt roof. Chimney is loose and torn flashing. GOOD-FAIR
Windows and Doors:	Newer replacement windows. GOOD
Exterior Walls:	Vinyl is GOOD
Porch, Stairs, Deck:	GODO
Foundation:	Can't see
Storefront/Signage:	
Parking Lots:	
Other Conditions:	
Overall Property Rating:	Good

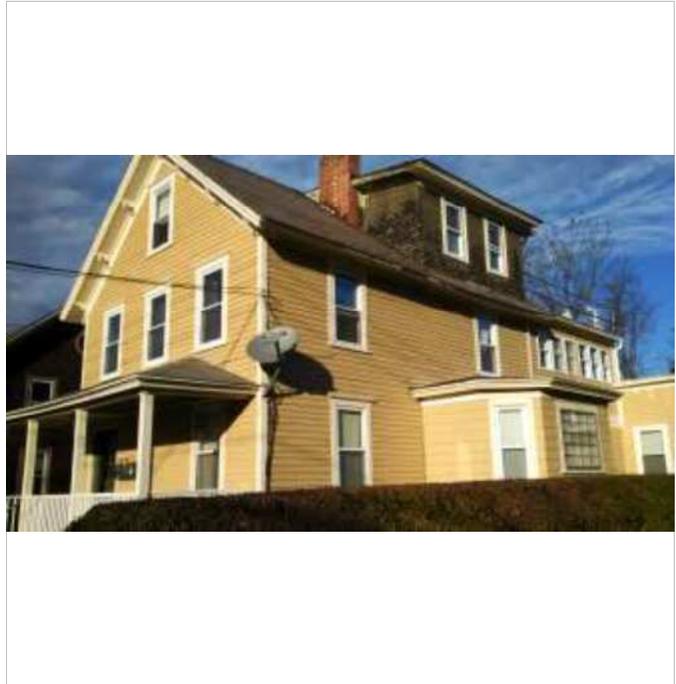
Roofing:	Chimney is in very poor condition with missing flashing and crumbling, loose brick; More than 25% of slate is missing/cracked. POOR
Windows and Doors:	Windows have been replaced recently. GOOD
Exterior Walls:	Siding has been newly painted. GOOD
Porch, Stairs, Deck:	The porch has recently been redone. GOOD
Foundation:	Cement on top of brick. The cement is crumbling off. FAIR
Storefront/Signage:	<input type="text"/>
Parking Lots:	<input type="text"/>
Other Conditions:	<input type="text"/>
Overall Property Rating:	Good-Fair

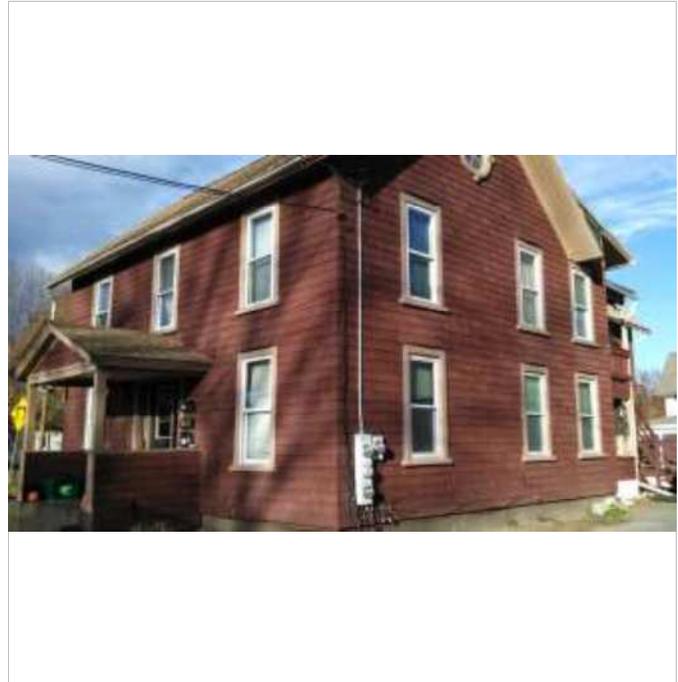
<u>Component</u>	<u>Condition</u>
Roofing:	Asphalt shingles are new. GOOD
Windows and Doors:	Windows are replacement windows. GOOD
Exterior Walls:	25% of shingles are missing and rotted at bottom of walls. FAIR
Porch, Stairs, Deck:	Steps and decks are in good condition. GOOD
Foundation:	Made of brick, less than 25% need repair. GOOD
Storefront/Signage:	<input type="text"/>
Parking Lots:	<input type="text"/>
Other Conditions:	<input type="text"/>
Overall Property Rating:	Good

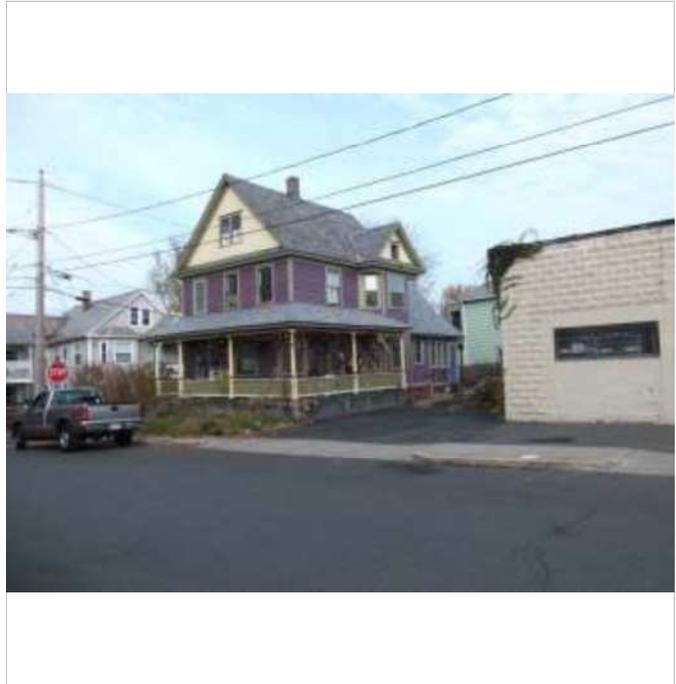
Roofing:	More than 50% of slate shingles are cracked. POOR
Windows and Doors:	Original windows starting to rot and need replacement. POOR
Exterior Walls:	25% of paint is peeling. FAIR
Porch, Stairs, Deck:	GOOD
Foundation:	Brick is GOOD
Storefront/Signage:	
Parking Lots:	
Other Conditions:	
Overall Property Rating:	Fair

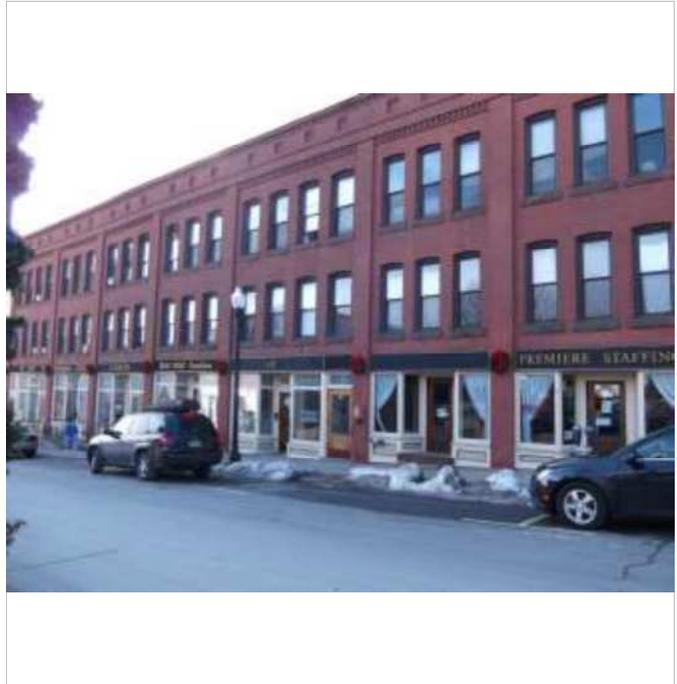
50-3

Roofing:	Flat - can't see.
Windows and Doors:	Windows are older, but in GOOD condition.
Exterior Walls:	Some bricks are chipped and need repointing, but less than 25%. GOOD
Porch, Stairs, Deck:	
Foundation:	Can't see.
Storefront/Signage:	Signage is updated and storefronts are freshly painted. GOOD
Parking Lots:	
Other Conditions:	
Overall Property Rating:	Good

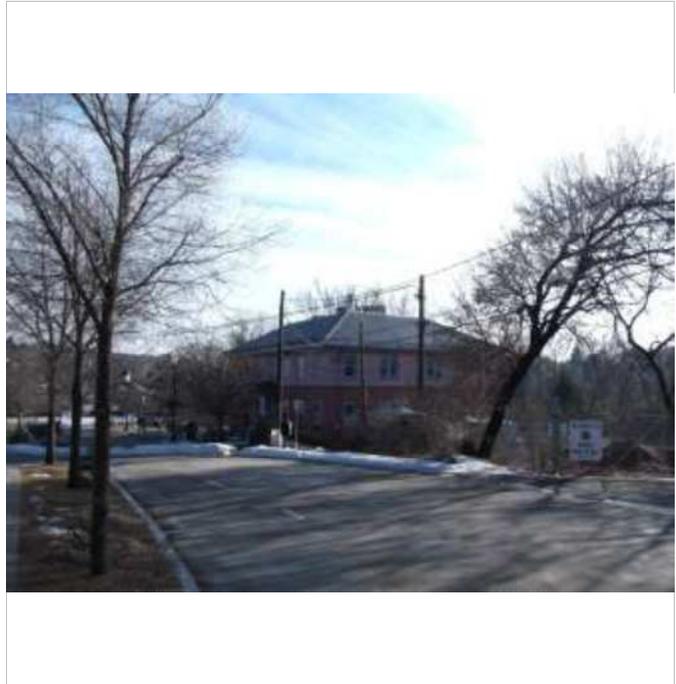
Roofing:	25% of slate shingles are in need of repair. Soffet is rotting and peeling paint. FAIR
Windows and Doors:	Windows are newer. GOOD
Exterior Walls:	Stucco is GOOD.
Porch, Stairs, Deck:	
Foundation:	Can't see.
Storefront/Signage:	GOOD
Parking Lots:	
Other Conditions:	
Overall Property Rating:	Good

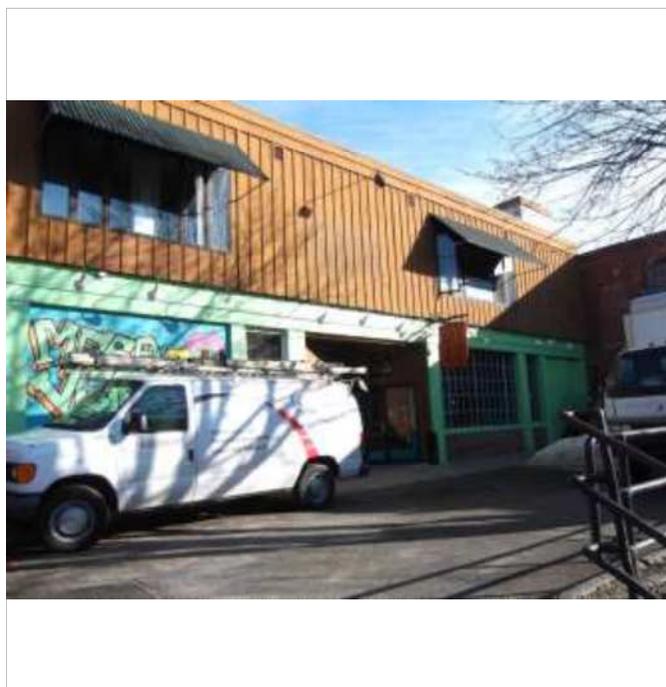
ID: 51-88

<u>Component</u>	<u>Condition</u>
Roofing:	Flat - can't see
Windows and Doors:	Windows and doors are newer. GOOD
Exterior Walls:	Freshly painted. GOOD
Porch, Stairs, Deck:	
Foundation:	Can't see
Storefront/Signage:	Signage is updated. GOOD
Parking Lots:	
Other Conditions:	
Overall Property Rating:	Good

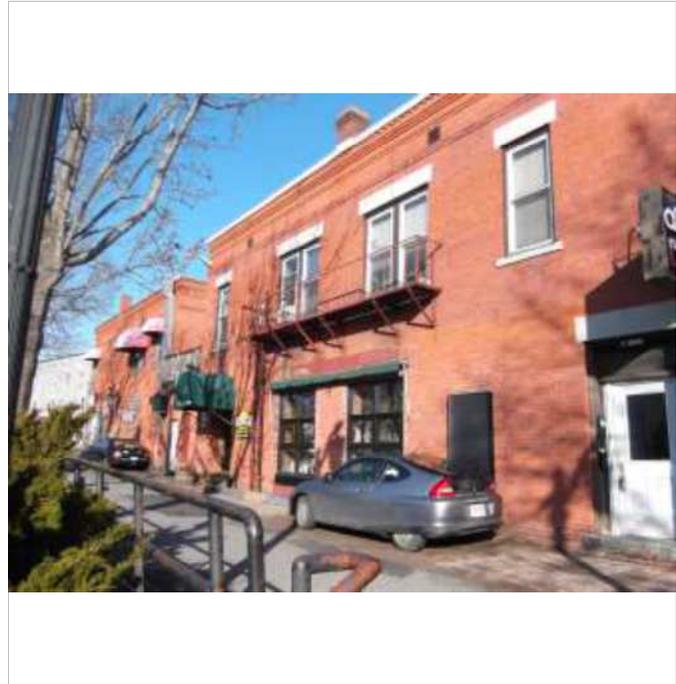
51-85

Roofing:	Flat - can't see
Windows and Doors:	Windows are in GOOD condition.
Exterior Walls:	Brick is in GOOD shape.
Porch, Stairs, Deck:	
Foundation:	Can't see
Storefront/Signage:	Signage is updated. GOOD
Parking Lots:	
Other Conditions:	
Overall Property Rating:	Good

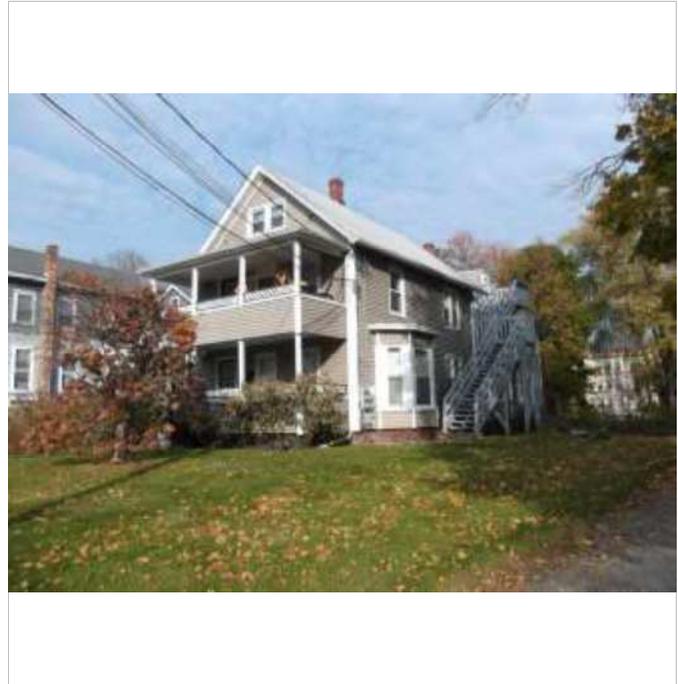
Roofing:	Asphalt shingles are GOOD
Windows and Doors:	Windows have been recently replaced. GOOD
Exterior Walls:	Vinyl siding is newer. GOOD
Porch, Stairs, Deck:	Porch and stairs are solid with no peeling paint. GOOD
Foundation:	25% of brick needs repointing. FAIR
Storefront/Signage:	<input type="text"/>
Parking Lots:	<input type="text"/>
Other Conditions:	<input type="text"/>
Overall Property Rating:	Good

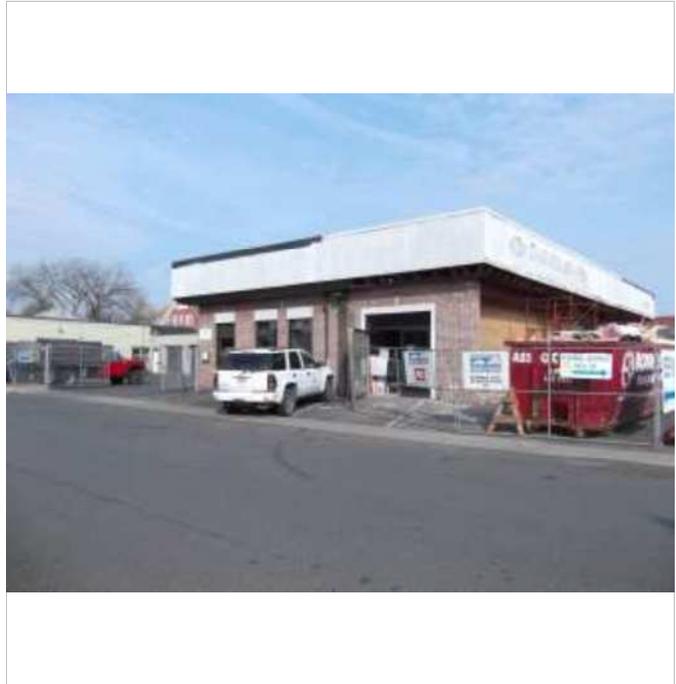
Roofing:	1/2 building is currently being renovated. Other building has 50% missing flashing. FAIR
Windows and Doors:	Older windows. FAIR
Exterior Walls:	25% of paint is peeling. FAIR
Porch, Stairs, Deck:	
Foundation:	
Storefront/Signage:	Faded signage. Storefront has rotting shingles and older wood siding. FAIR
Parking Lots:	
Other Conditions:	There are 2 buildings. 1 is being renovated.
Overall Property Rating:	Good-Fair

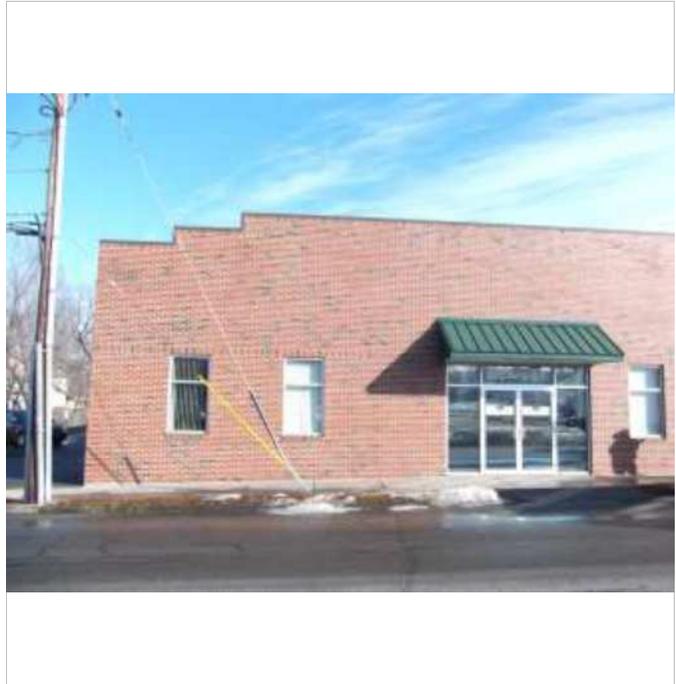
57-68

Roofing:	Flat - can't see.
Windows and Doors:	Windows and doors are in GOOD shape.
Exterior Walls:	Brick and mortar is GOOD
Porch, Stairs, Deck:	
Foundation:	Can't see
Storefront/Signage:	GOOD
Parking Lots:	
Other Conditions:	
Overall Property Rating:	Good

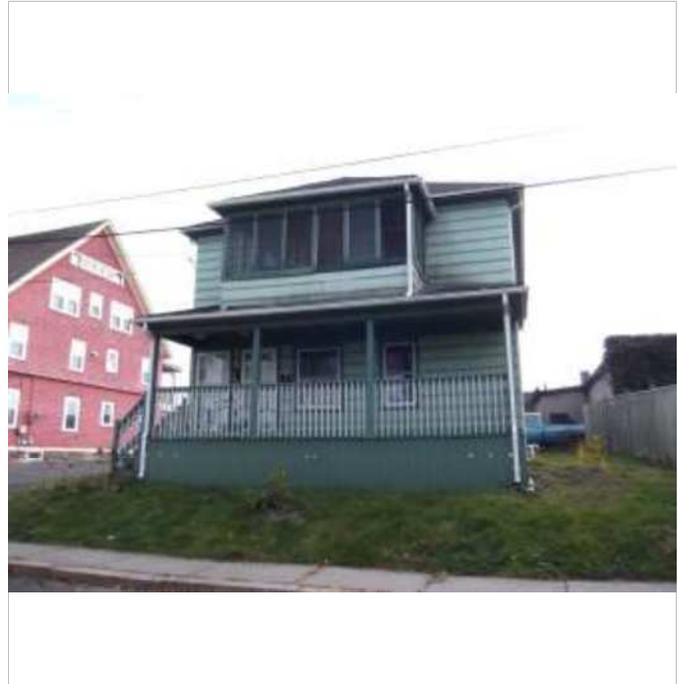
59-8

Roofing:	25% of shingles are lifting away and needs repair. FAIR
Windows and Doors:	Trim on most windows are rotting. Very energy inefficient. FAIR
Exterior Walls:	25% of asbestos is cracked and stained. FAIR
Porch, Stairs, Deck:	Front steps are rotted. POOR
Foundation:	Stone is GOOD
Storefront/Signage:	
Parking Lots:	
Other Conditions:	
Overall Property Rating:	Fair-Poor

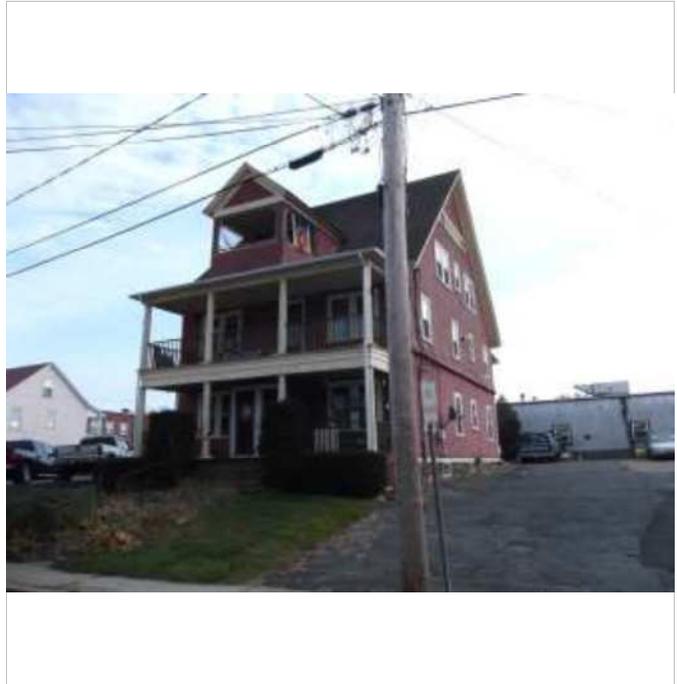
ID: 59-7

<u>Component</u>	<u>Condition</u>
Roofing:	25% of shingles need repair. FAIR
Windows and Doors:	Windows are newer. GOOD
Exterior Walls:	Shingles are freshly painted. 25% of shingles are loose. FAIR
Porch, Stairs, Deck:	Railings need replacement. Floorboards are coming loose. Paint is peeling/faded. POOR
Foundation:	A mix of stone/brick, which is cracked and loose. POOR
Storefront/Signage:	
Parking Lots:	
Other Conditions:	
Overall Property Rating:	Fair

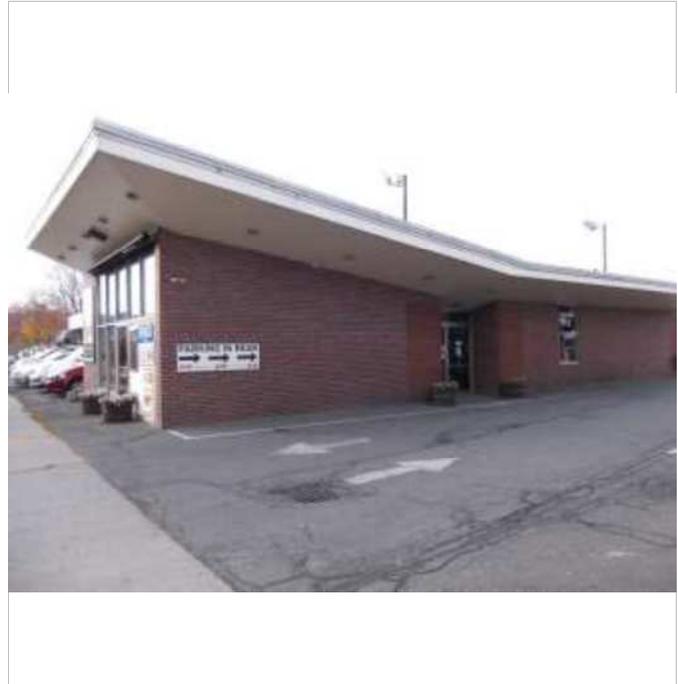
59-86A

Roofing:	Rubber lining. GOOD
Windows and Doors:	Older, but GOOD.
Exterior Walls:	Brick is GOOD
Porch, Stairs, Deck:	
Foundation:	Can't observe
Storefront/Signage:	GOOD
Parking Lots:	cracked and uneven. FAIR
Other Conditions:	
Overall Property Rating:	Good

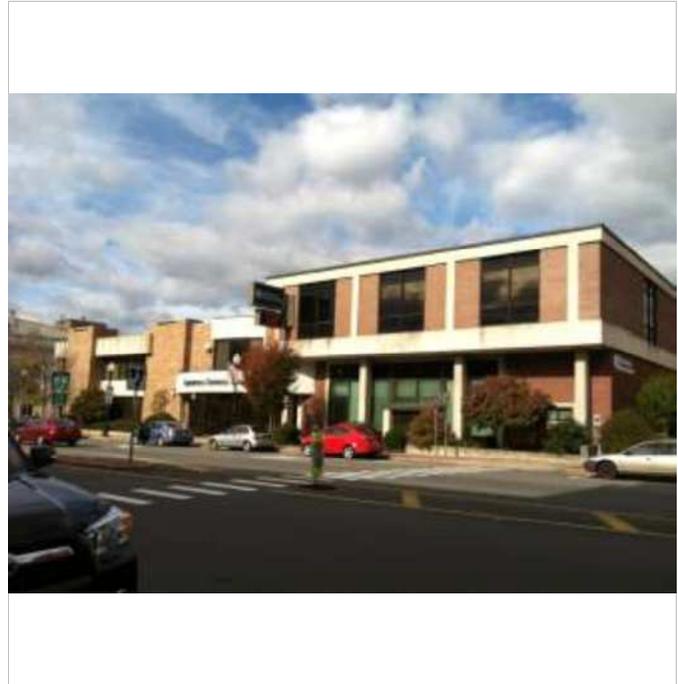
56-1

<u>Component</u>	<u>Condition</u>
Roofing:	Flat - can't see.
Windows and Doors:	Windows and doors are GOOD.
Exterior Walls:	Brick is good, although cement has discoloring. GOOD
Porch, Stairs, Deck:	more than 25% of concrete walkway is cracked. FAIR
Foundation:	Can't see.
Storefront/Signage:	GOOD
Parking Lots:	GOOD
Other Conditions:	
Overall Property Rating:	Good

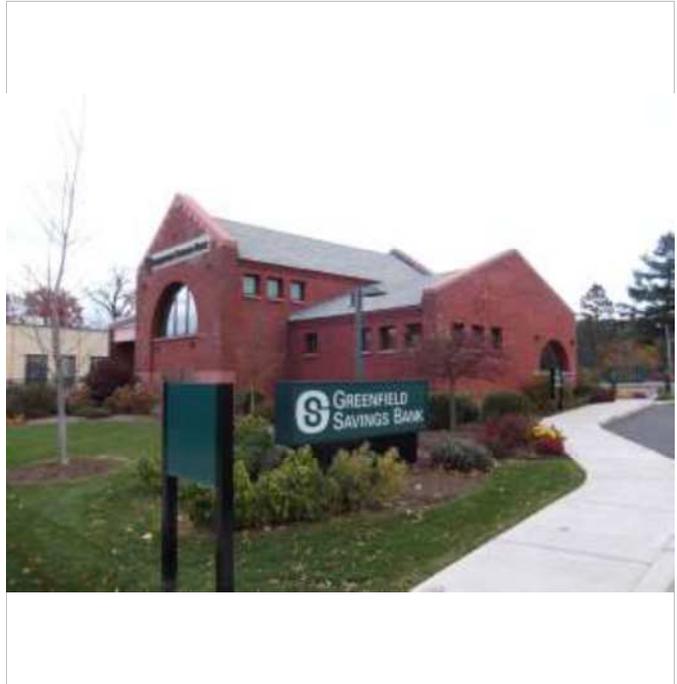
Roofing:	<input type="text"/>
Windows and Doors:	<input type="text"/>
Exterior Walls:	<input type="text"/>
Porch, Stairs, Deck:	<input type="text"/>
Foundation:	<input type="text"/>
Storefront/Signage:	<input type="text"/>
Parking Lots:	<input type="text" value="GOOD"/>
Other Conditions:	<input type="text"/>
Overall Property Rating:	<input type="text" value="Good"/>

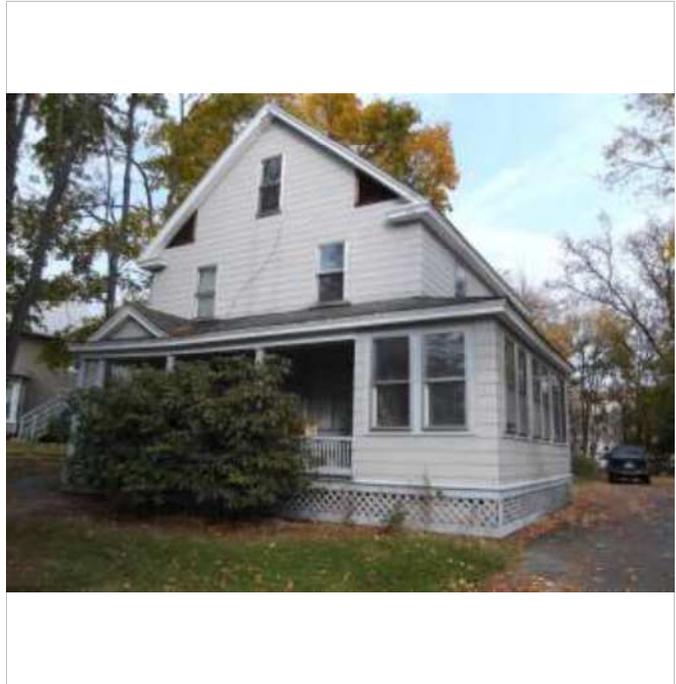
Roofing:	Slate and asphalt shingles are newer. GOOD
Windows and Doors:	Windows are older aluminum and beyond useful life. POOR
Exterior Walls:	25% of asbestos is loose and cracked. FAIR
Porch, Stairs, Deck:	Porch is rotted and sagging. POOR
Foundation:	At least 50% of bricks in foundation are loose. POOR
Storefront/Signage:	<input type="text"/>
Parking Lots:	<input type="text"/>
Other Conditions:	<input type="text"/>
Overall Property Rating:	Poor

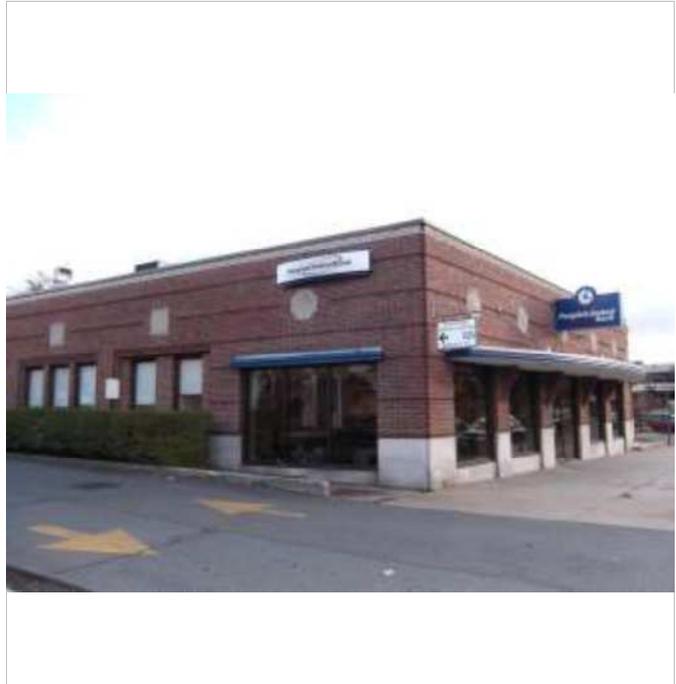
56-28

Roofing:	Flat - can't see.
Windows and Doors:	Newer windows. GOOD
Exterior Walls:	Brick is GOOD.
Porch, Stairs, Deck:	
Foundation:	Can't see.
Storefront/Signage:	Newer signage and storefront roof. GOOD
Parking Lots:	
Other Conditions:	
Overall Property Rating:	Good

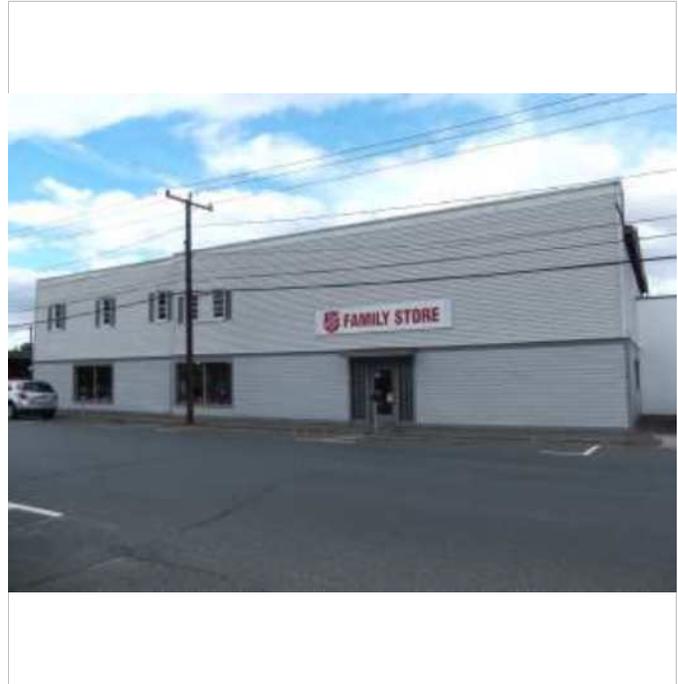
Roofing:	<input type="text" value="2 roofs flat - can't see. 1 roof has loose, torn asphalt - poor."/>
Windows and Doors:	<input type="text" value="Building A has new windows. Building C has broken/boarded up windows - poor. Building B has energy inefficient windows - fair. FAIR"/>
Exterior Walls:	<input type="text" value="Building C has loose shingles and rotting wood. Buildings A and B are GOOD"/>
Porch, Stairs, Deck:	<input type="text"/>
Foundation:	<input type="text" value="Building C has cracked foundation. POOR"/>
Storefront/Signage:	<input type="text" value="Building A is new. Building B has rotted trim and sills. Building C has rotting/loose wood."/>
Parking Lots:	<input type="text"/>
Other Conditions:	<input type="text" value="Junked cars in front of Building C"/>
Overall Property Rating:	<input type="text" value="Fair"/>

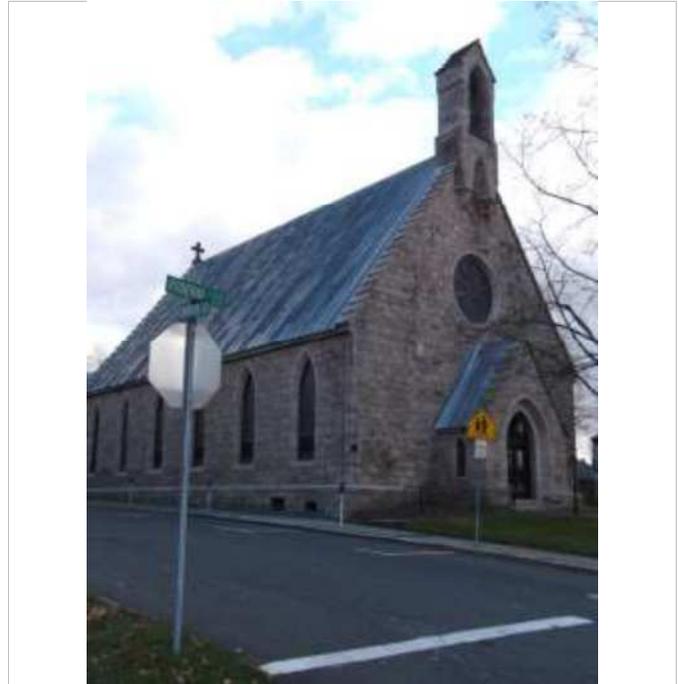
56-19

Roofing:	Metal sheeting. GOOD
Windows and Doors:	Stained glass windows. GOOD
Exterior Walls:	Stone is in GOOD condition.
Porch, Stairs, Deck:	GOOD
Foundation:	
Storefront/Signage:	GOOD
Parking Lots:	GOOD
Other Conditions:	
Overall Property Rating:	Good
