December 2014

FRANKLIN
REGIONAL
COUNCIL OF
GOVERNMENTS

SLUM AND BLIGHT INVENTORY FOR THE TOWN OF GREENFIELD

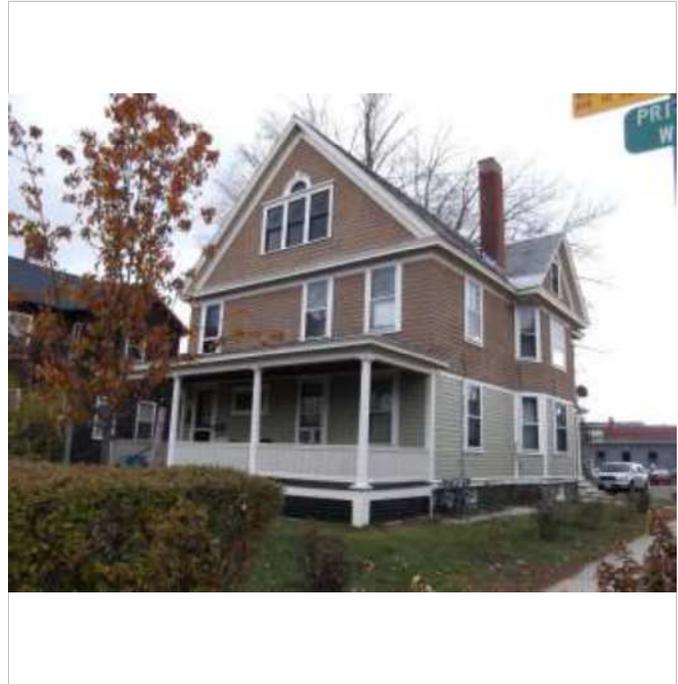
Roofing:	More than 25% of slate shingles are chipped and lifted away. FAIR
Windows and Doors:	Older and energy inefficient. FAIR
Exterior Walls:	Freshly painted. GOOD
Porch, Stairs, Deck:	Freshly painted porch with new stairs. GOOD
Foundation:	Stone is GOOD.
Storefront/Signage:	<input type="text"/>
Parking Lots:	<input type="text"/>
Other Conditions:	<input type="text"/>
Overall Property Rating:	Good

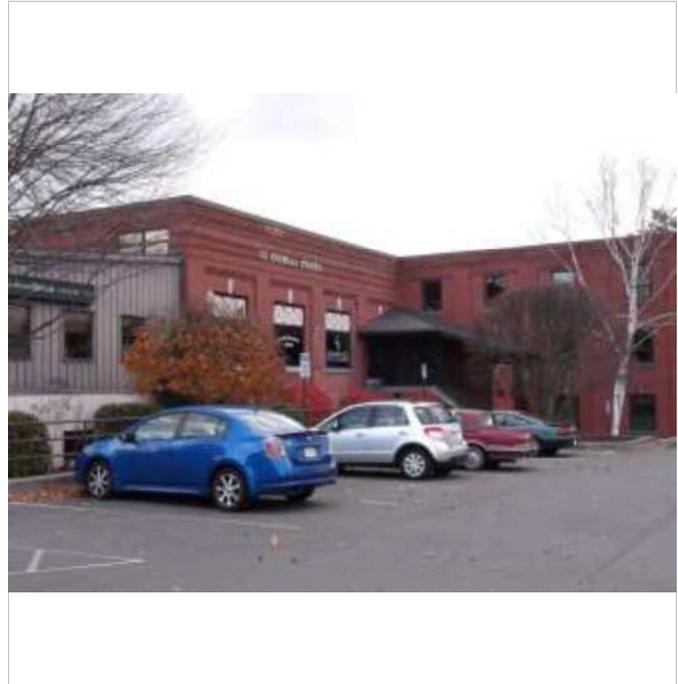
Roofing:	<input type="text" value="Flat - can't see."/>
Windows and Doors:	<input type="text" value="Windows are in GOOD condition."/>
Exterior Walls:	<input type="text" value="Brick is GOOD"/>
Porch, Stairs, Deck:	<input type="text" value="Cement porch is GOOD"/>
Foundation:	<input type="text" value="Can't see"/>
Storefront/Signage:	<input type="text" value="GOOD"/>
Parking Lots:	<input type="text" value="Asphalt surface is smooth. GOOD"/>
Other Conditions:	<input type="text"/>
Overall Property Rating:	<input type="text" value="Good"/>

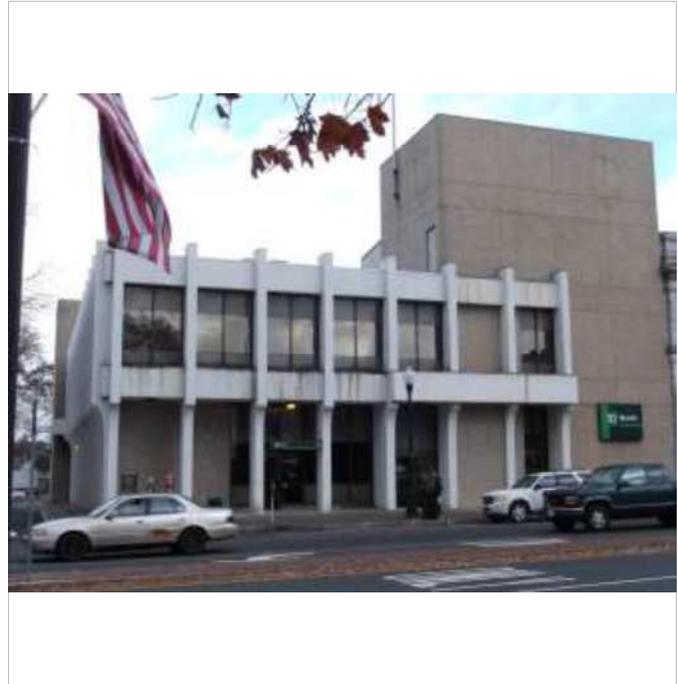
51-33

Roofing:	Concrete trim is crumbling and flashing is rusting. FAIR
Windows and Doors:	Window trim is discolored. FAIR
Exterior Walls:	More than 25% of walls are stained and discolored. Upper section of concrete is cracked. Foundation is exposed from cracking. POOR
Porch, Stairs, Deck:	
Foundation:	Concrete block is exposed from cracked walls. POOR
Storefront/Signage:	GOOD
Parking Lots:	
Other Conditions:	
Overall Property Rating:	Fair

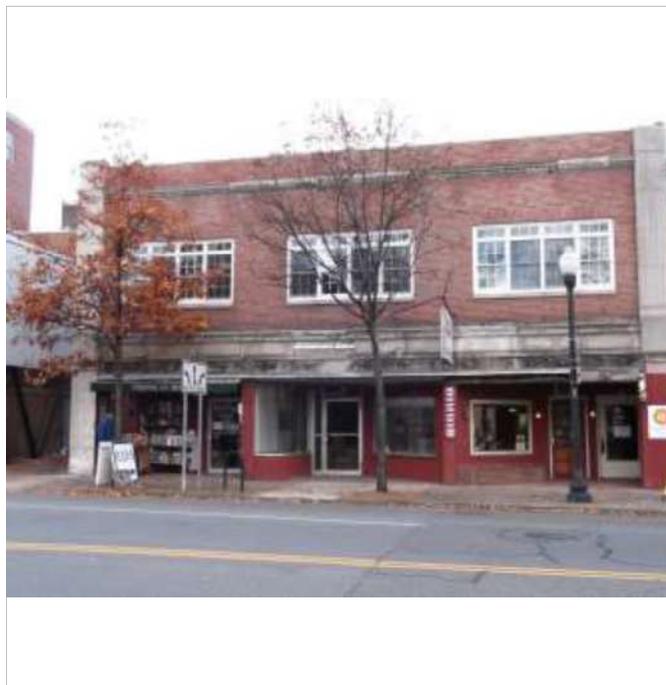
ID: 51-26

Roofing:	Can't observe
Windows and Doors:	Windows have broken glass and a poorly cemented window on side. FAIR-POOR
Exterior Walls:	Concrete façade is crumbling. Large pieces missing from dental trim. Concrete corner is cracked. POOR
Porch, Stairs, Deck:	
Foundation:	
Storefront/Signage:	Poorly painted wood storefront paneling. POOR
Parking Lots:	
Other Conditions:	
Overall Property Rating:	Poor

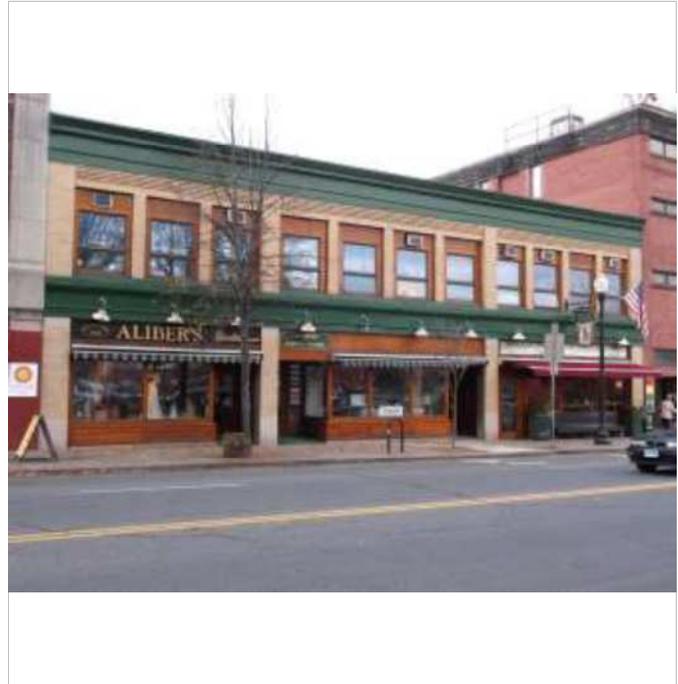
<u>Component</u>	<u>Condition</u>
Roofing:	Can't observe
Windows and Doors:	Windows in good condition. GOOD
Exterior Walls:	Brick is in good condition. GOOD
Porch, Stairs, Deck:	
Foundation:	Can't observe
Storefront/Signage:	Signage is in good condition and updated. GOOD
Parking Lots:	
Other Conditions:	
Overall Property Rating:	Good

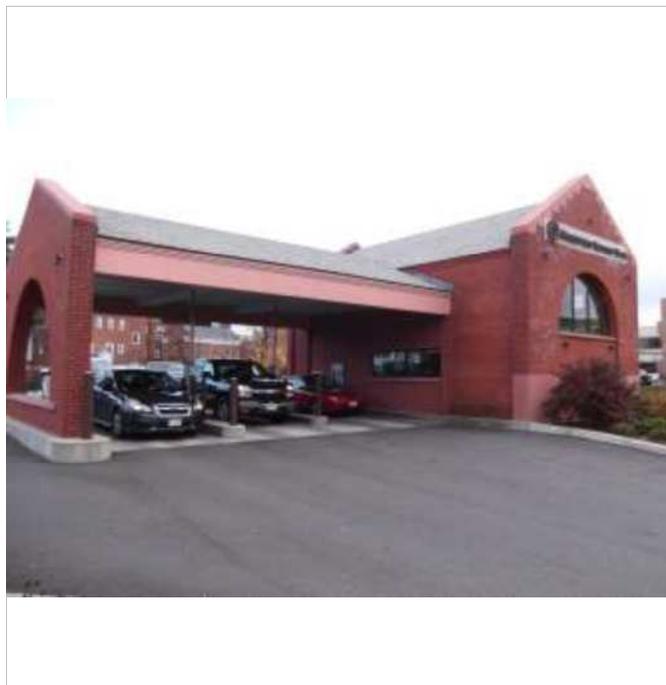
ID: 56-30

Roofing:	Asphalt is newer. GOOD
Windows and Doors:	Windows are newer. GOOD
Exterior Walls:	Brick has been repointed. GOOD
Porch, Stairs, Deck:	
Foundation:	Can't see
Storefront/Signage:	GOOD
Parking Lots:	GOOD
Other Conditions:	
Overall Property Rating:	Good

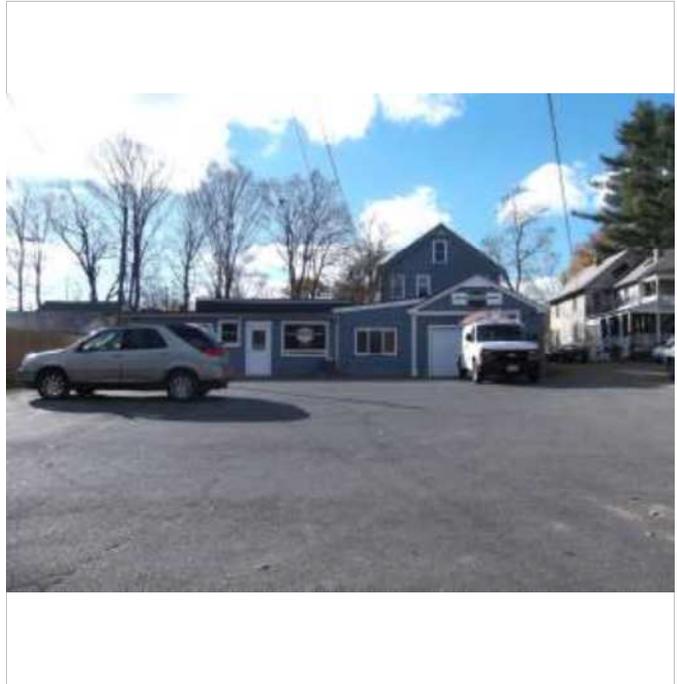
Roofing:	Roof is flat - can't see.
Windows and Doors:	Garage doors are warped, but windows are good. GOOD-FAIR
Exterior Walls:	Vinyl siding is GOOD
Porch, Stairs, Deck:	GOOD
Foundation:	Can't see
Storefront/Signage:	Signage is new and GOOD
Parking Lots:	Parking lot is recently repaved. GOOD
Other Conditions:	
Overall Property Rating:	Good

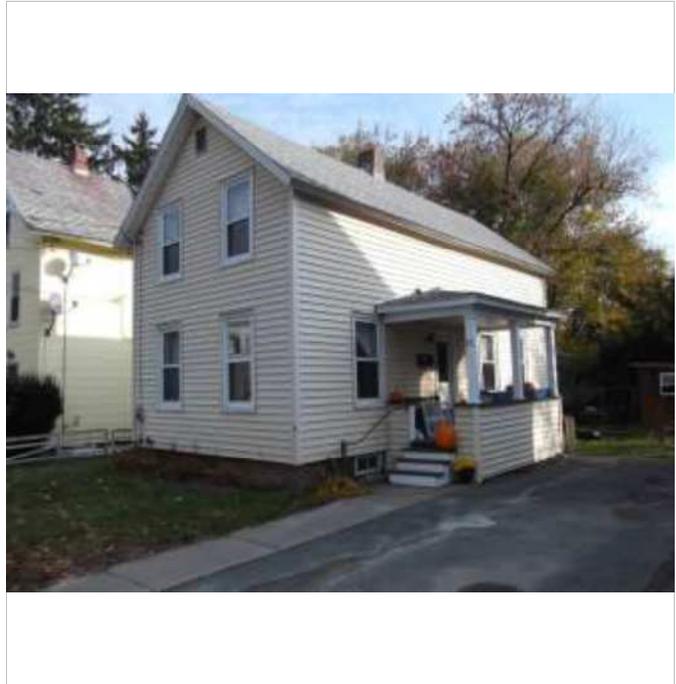
<u>Component</u>	<u>Condition</u>
Roofing:	New asphalt shingles. GOOD
Windows and Doors:	Windows have been recently replaced. GOOD
Exterior Walls:	Vinyl is relatively new. GOOD
Porch, Stairs, Deck:	GOOD
Foundation:	Brick is GOOD
Storefront/Signage:	
Parking Lots:	
Other Conditions:	
Overall Property Rating:	Good

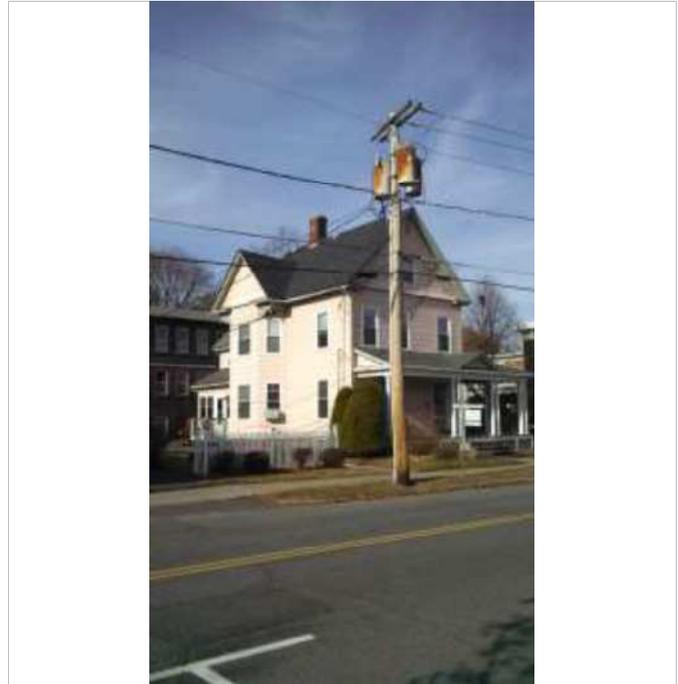
58-50

Roofing:	New roof. GOOD
Windows and Doors:	Trim and windows in good repair. GOOD
Exterior Walls:	Siding in good condition. GOOD
Porch, Stairs, Deck:	No railing, but in good condition. FAIR
Foundation:	Brick in good repair. GOOD
Storefront/Signage:	N/A
Parking Lots:	
Other Conditions:	
Overall Property Rating:	Good

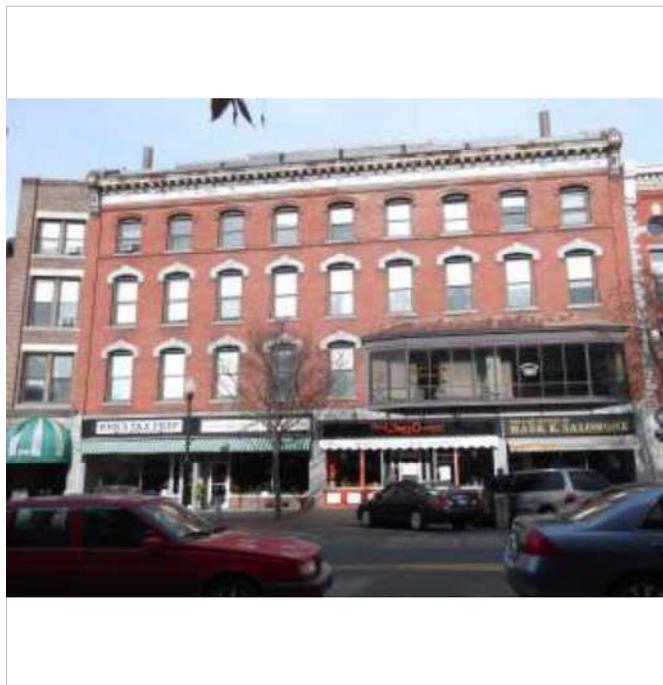
51-50

Roofing:	Dental work has rust stains and peeled paint. Flashing is torn. POOR
Windows and Doors:	Windows have broken mechanisms. Doors are older metal ones near useful life. FAIR
Exterior Walls:	Brick is GOOD
Porch, Stairs, Deck:	Front awning is ripped. Interior public foyer and stairway has a roof leak. POOR
Foundation:	Can't see
Storefront/Signage:	GOOD
Parking Lots:	
Other Conditions:	Tenants on top floor report that the roof leaks after every rain storm. Physical evidence of wat
Overall Property Rating:	Fair

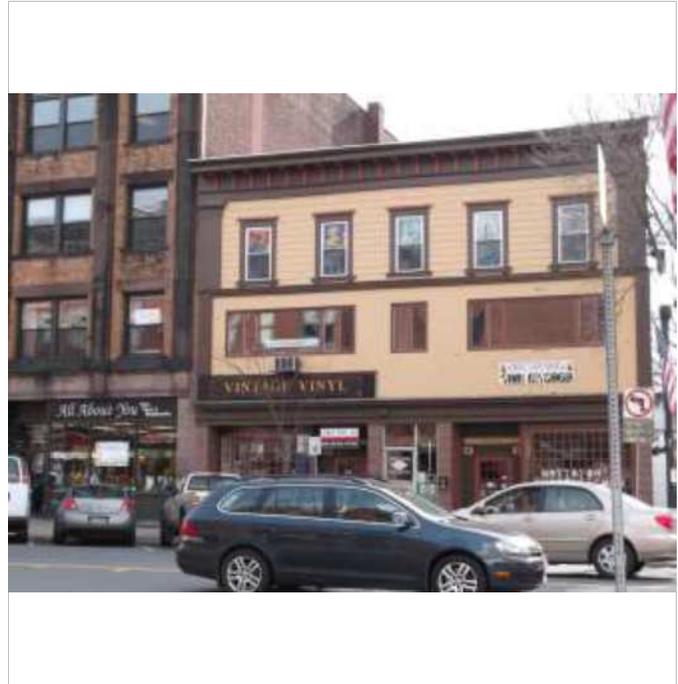
51-76

<u>Component</u>	<u>Condition</u>
Roofing:	Chimney has loose bricks. Roof is flat. FAIR
Windows and Doors:	GOOD
Exterior Walls:	Freshly painted wood siding. GOOD
Porch, Stairs, Deck:	
Foundation:	Can't see
Storefront/Signage:	GOOD
Parking Lots:	
Other Conditions:	
Overall Property Rating:	Good

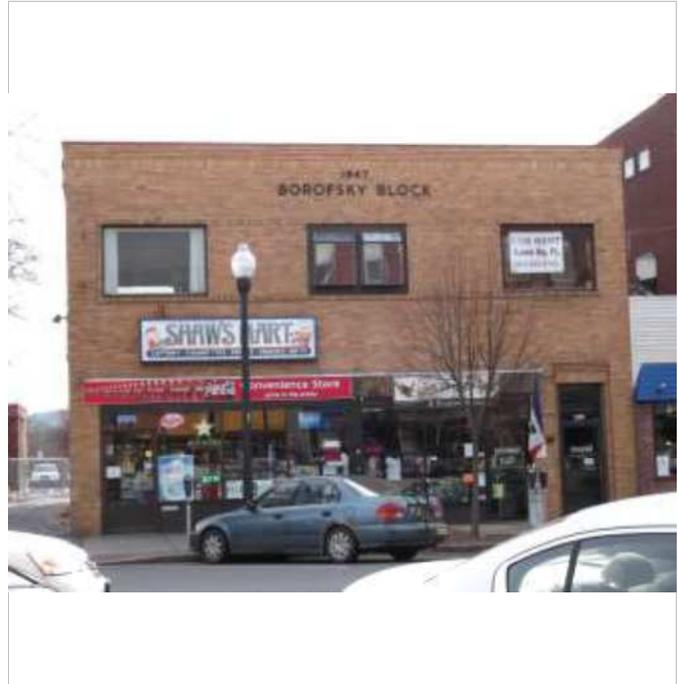
Roofing:	Flat - can't see.
Windows and Doors:	Older, metal windows. GOOD
Exterior Walls:	More than 25% of brick needs repointing and has cracks. FAIR
Porch, Stairs, Deck:	
Foundation:	Can't see
Storefront/Signage:	Older, outdated signage. Wood above windows is unpainted and worn. Metal beneath windo
Parking Lots:	
Other Conditions:	
Overall Property Rating:	Fair

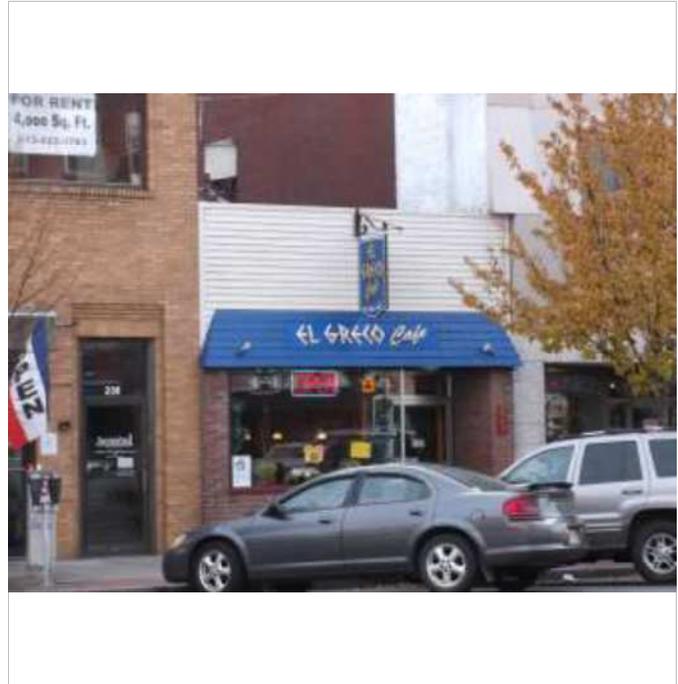
Roofing:	<input type="text" value="Flat - can't see."/>
Windows and Doors:	<input type="text" value="Older windows. GOOD"/>
Exterior Walls:	<input type="text" value="Vinyl and brick are GOOD"/>
Porch, Stairs, Deck:	<input type="text"/>
Foundation:	<input type="text" value="Can't see"/>
Storefront/Signage:	<input type="text" value="Signage is updated. GOOD"/>
Parking Lots:	<input type="text"/>
Other Conditions:	<input type="text"/>
Overall Property Rating:	<input type="text" value="Good"/>

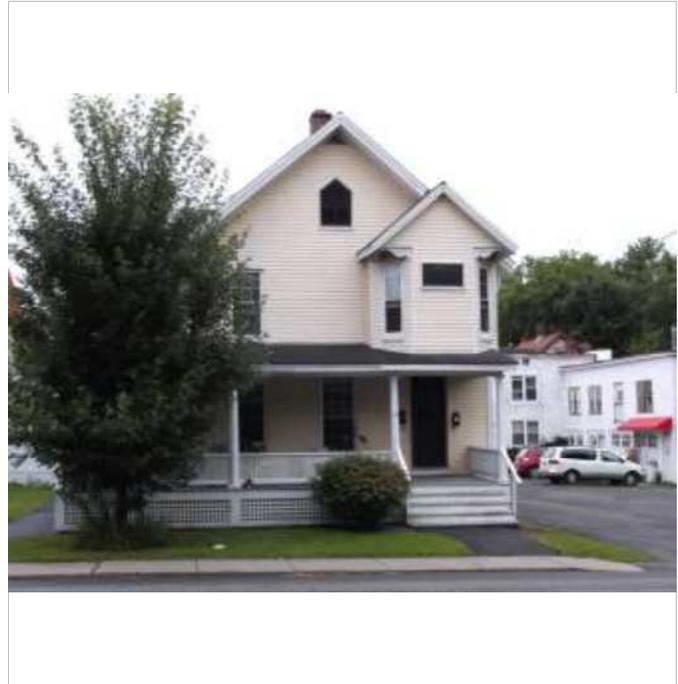
Roofing:	Slate roof in GOOD condition.
Windows and Doors:	Windows are newly replaced. GOOD
Exterior Walls:	Vinyl siding is in GOOD condition.
Porch, Stairs, Deck:	Newly painted and repaired. GOOD
Foundation:	Brick. GOOD
Storefront/Signage:	<input type="text"/>
Parking Lots:	<input type="text"/>
Other Conditions:	<input type="text"/>
Overall Property Rating:	Good

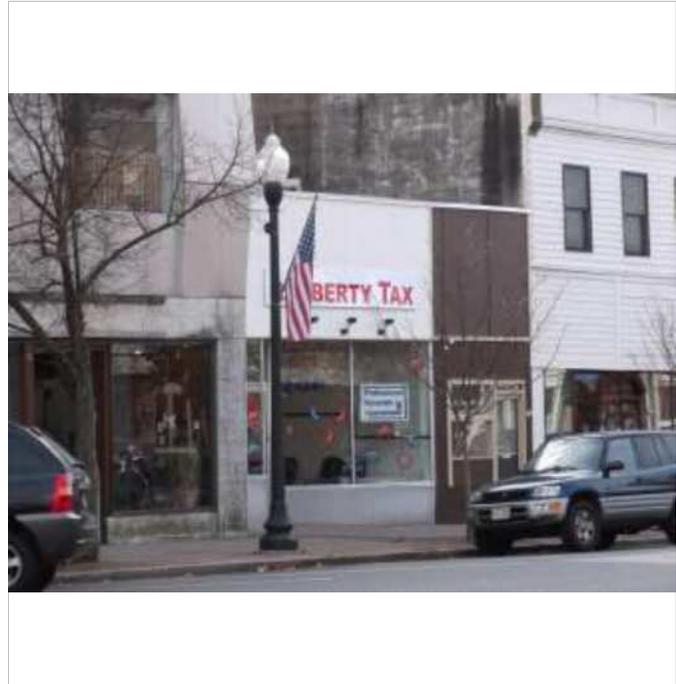
Roofing:	<input type="text" value="Flat - can't see"/>
Windows and Doors:	<input type="text" value="Older windows and energy inefficient. FAIR"/>
Exterior Walls:	<input type="text" value="Panels are stained and loose. FAIR"/>
Porch, Stairs, Deck:	<input type="text"/>
Foundation:	<input type="text" value="Can't see"/>
Storefront/Signage:	<input type="text" value="Temporary signage. FAIR"/>
Parking Lots:	<input type="text"/>
Other Conditions:	<input type="text"/>
Overall Property Rating:	<input type="text" value="Fair"/>

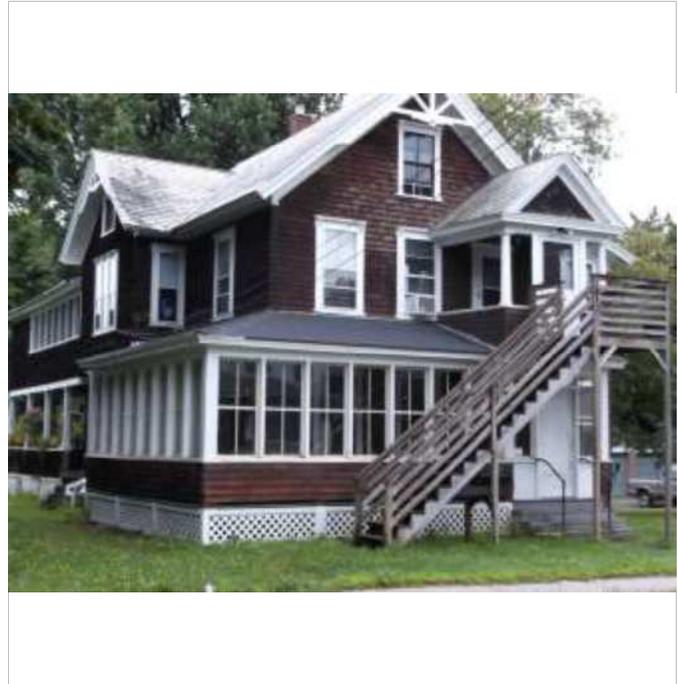
<u>Component</u>	<u>Condition</u>
Roofing:	Slate roof with many broken loose shingles. Chimney needs mortar. Flashing lifting off. Tarp covering porch roof. POOR
Windows and Doors:	Original windows with storm windows. Door is older and ill-fitting and needs paint. FAIR
Exterior Walls:	Wood shingles with few that are loose. GOOD
Porch, Stairs, Deck:	Stairs are slanted and have rotting floorboards. Porch and stairs to 2nd floor is newer. GOOD
Foundation:	Brick. GOOD
Storefront/Signage:	
Parking Lots:	
Other Conditions:	
Overall Property Rating:	Fair

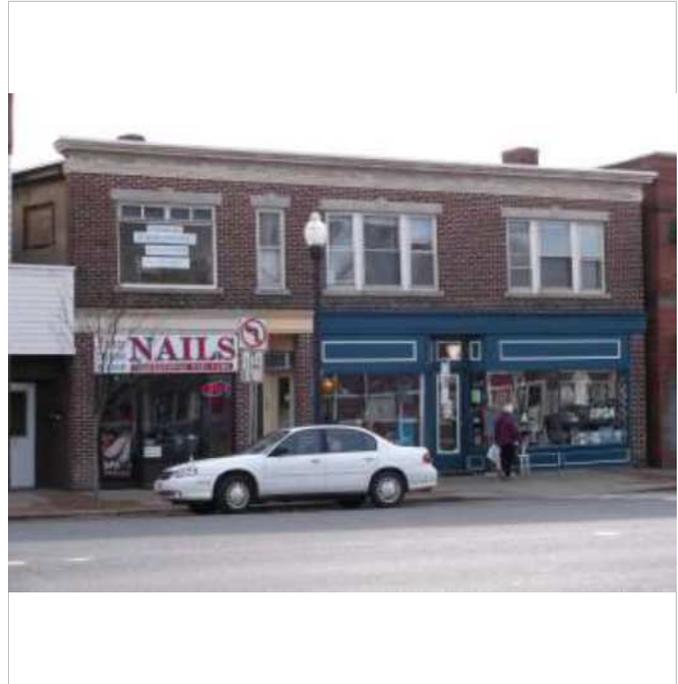
<u>Component</u>	<u>Condition</u>
Roofing:	Flashing is loose and paint on soffets have completely peeled off. Chimney bricks need to be repointed. POOR
Windows and Doors:	Older windows are loose fitting, with broken mechanisms. Paint has peeled off trims. POOR
Exterior Walls:	25% of brick needs repointing. Cement on side walls are cracked. FAIR
Porch, Stairs, Deck:	
Foundation:	Can't see
Storefront/Signage:	Paint along storefronts are peeling. One store has old and outdated sign. Other store does not
Parking Lots:	
Other Conditions:	
Overall Property Rating:	Fair
